Coleshill Uncovered

Interim Report

March 2011

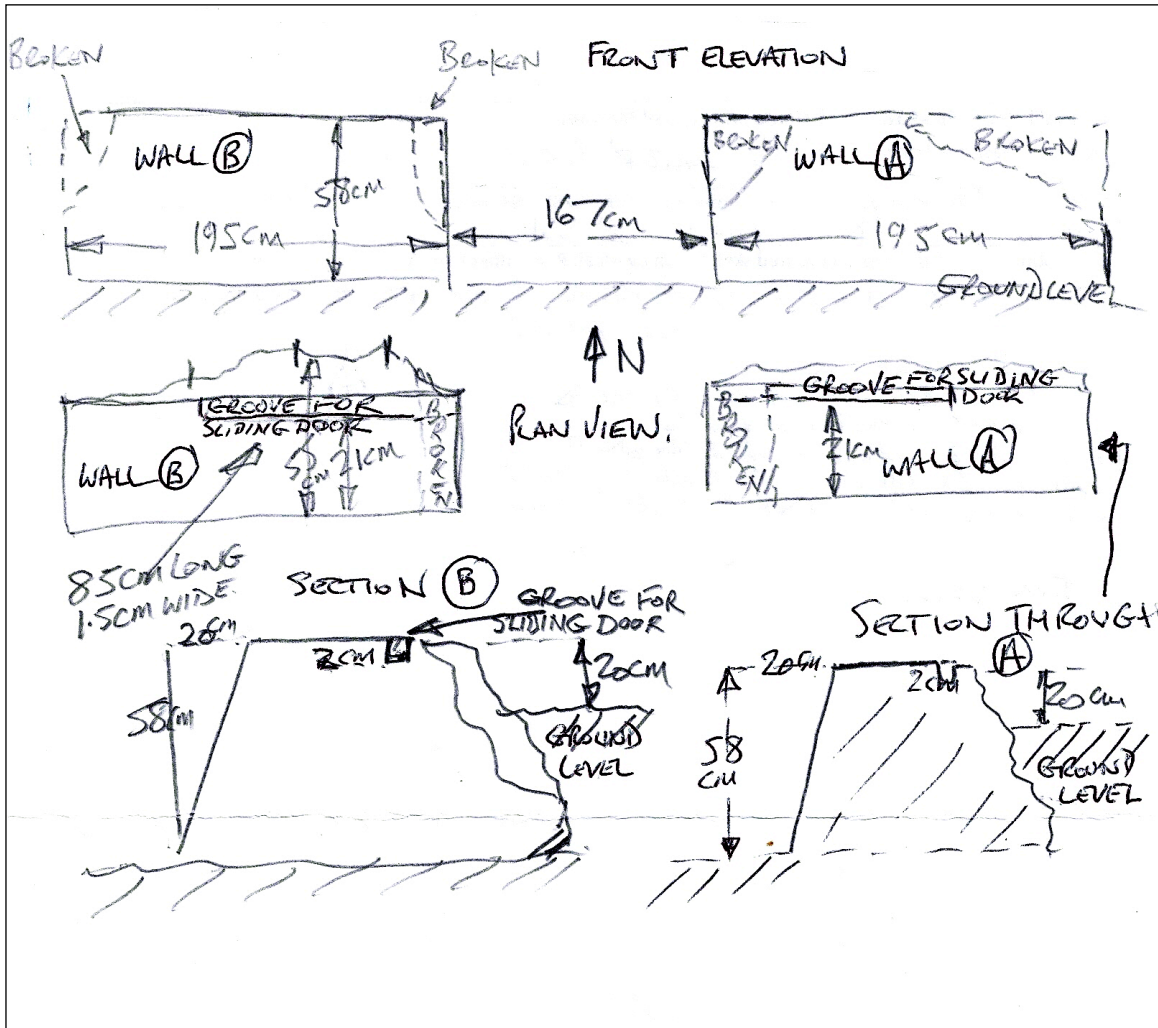
Structure 2 (Generator room), continued.

Two lumps of concrete, spaced 1.06m apart and located to the west of Structure 5, have always been thought to be the remains of a Generator Base. Orientated so that they run east-west neither seem to be complete, however they both have flat screed surfaces on both their east and west ends and therefore do seem to be their original lengths; 1.96m (western plinth) and 1.88m (eastern plinth).

The southern faces slope vertically so that they are 'tipping' north, and the top of the concrete plinths sits 0.58m above the current ground level on it's southern side and 0.20m above current ground level on it's northern side. The depth below current ground level is unknown as we were unable to excavate at this stage. The Western of the two plinths has a bare concrete southern face that has shuttering marks on it, evidence of the method of construction. The Eastern plinth however has been faced with mortar on it's southern face – was the structure originally clad with something else?

The northern faces are vertical, both are also very rough and it seems that this was not the full extent of the original feature. On both of the northern faces there is evidence of post holes that are probably part of the original construction method. There are also metal rods protruding from the concrete in both the Eastern and Western plinths that are presumably there for reinforcing purposes.

The top of both plinths are mainly flat finished, however some areas are rough where they have broken off over the years. Both the Eastern and Western plinths have a groove running along the northern edge of their top face. This groove is 0.85m long on the Western plinth and 0.7m long on the Eastern plinth, 150mm wide and 200mm deep and sits 0.21m from the southern edge of the plinths. The grooves do not run along the full length of the top face but sit so that they meet at the gap between the plinths (i.e. the groove on the Western plinth sits on it's eastern side and the groove on the Eastern plinth sits on it's western side). It is believed that this is a groove for a sliding door for whatever structure was originally located here. A
