Supplemental report on suspected firing range, possibly used by Auxiliary Units in woods between Faringdon and Coleshill.

**Dr William Ward
March 2014**

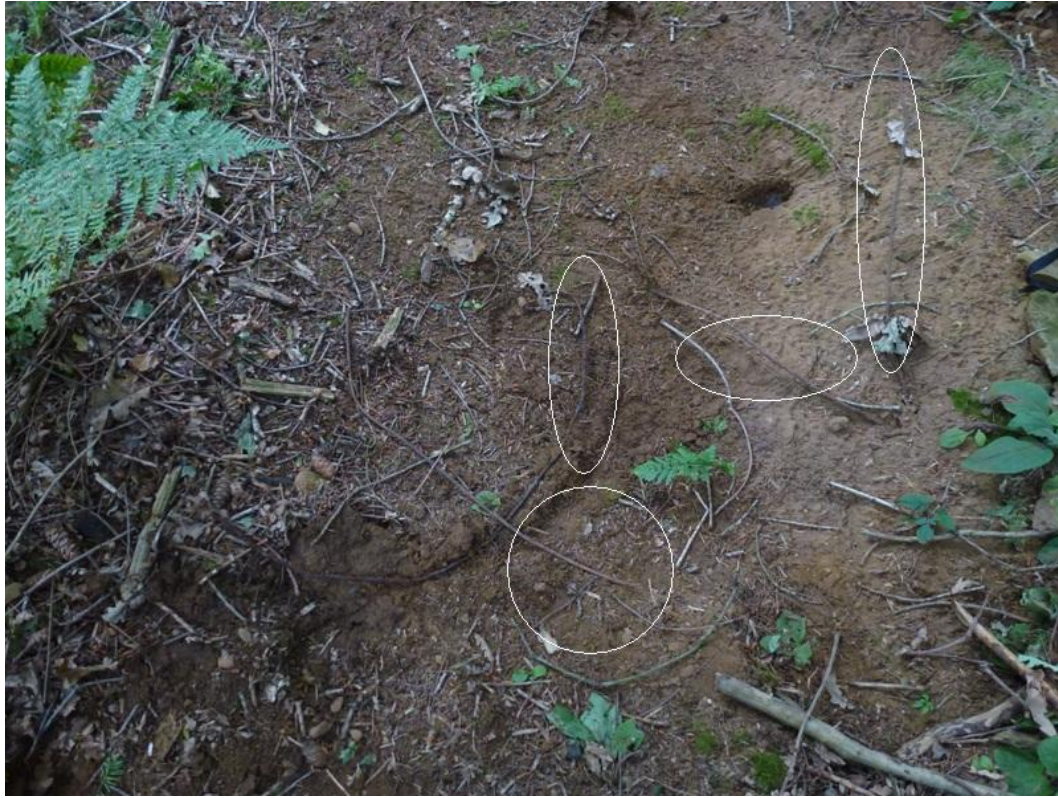
Fig 1.
23rd September 2013.
Lengths of metal cable circled, standing proud of the bank surface following erosion.

The finding of a large amount of metal cabling in a very rusted condition so close to the site suggests this may have been a part of the wartime structure. Firing ranges often had suspended targets and sometime moving targets. This cabling may have formed a part of such structures. Often as sites were dismantled at the end of the war, items that could not be usefully recycled would be buried in pits. The finding of apparent coils of cable eroding out of the bank would be consistent with this type of disposal.

The March 2014 visit has found that extensive damage has occurred with the building of large ramps for off road cycling. This has involved excavation of sand to build the structures and is already encroaching on the known archaeological remains. It is recommended that the central range area be fenced off to prevent further damage. A metal detector survey, without more extensive excavation, but with GPS finds recording, could identify if there are any other areas of metal finds that ought to be preserved for future investigation. The areas of metal cabling protruding from the surface are also a potential danger to cyclists and walkers and therefore ought to be either fenced off, or excavated and removed.

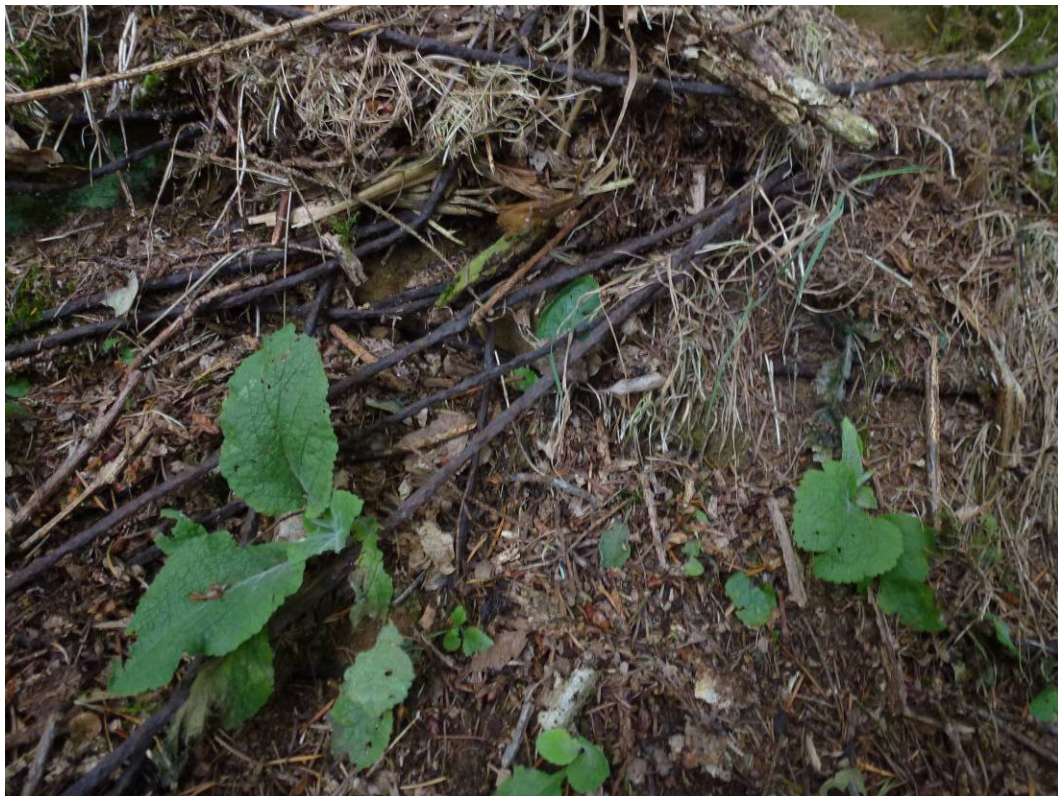
Fig 2.
23rd September 2013.
Multiple strands of rusted metal cable lying parallel exposed on edge of bank.

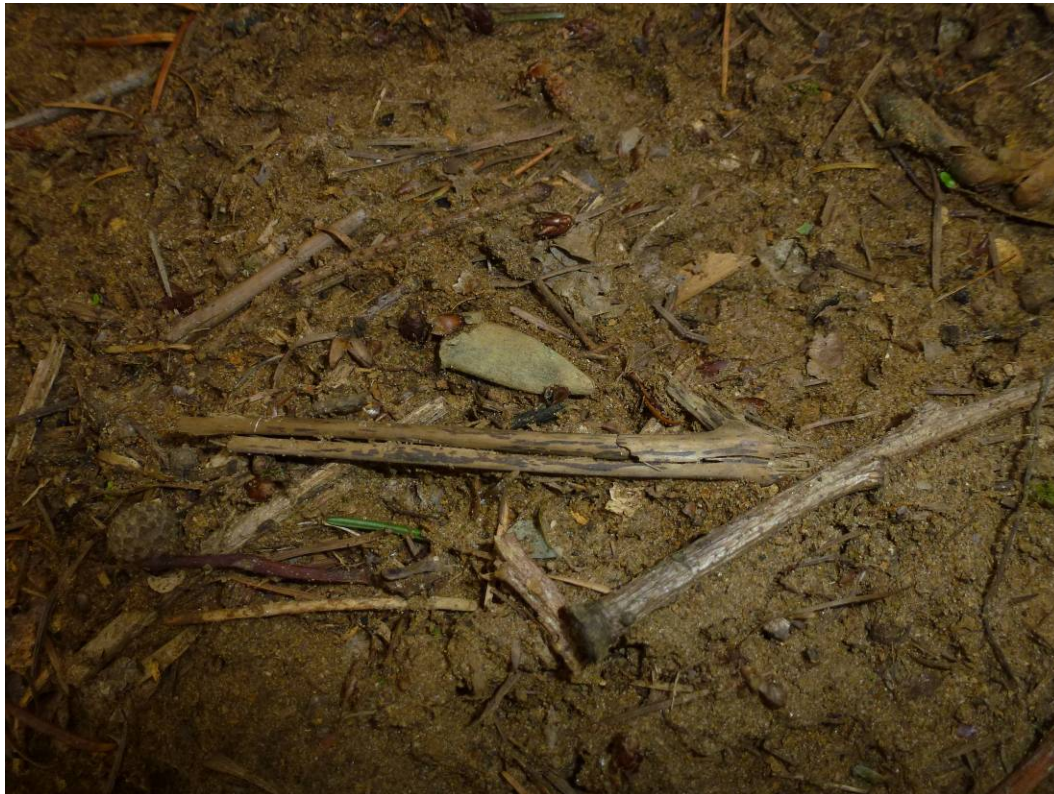
Fig 3.
23rd September 2013.
National Grid Reference 25730 94780
Bullet 5 as found on surface.

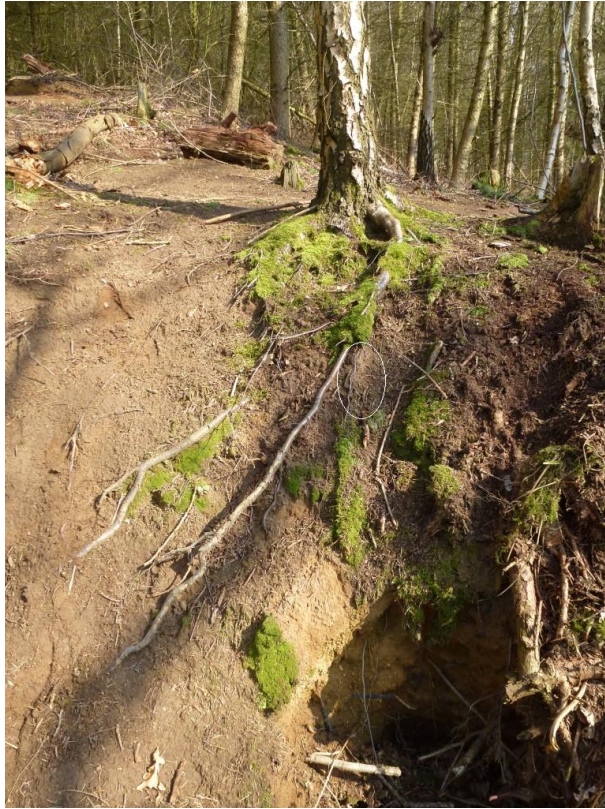
Fig 4.
27th March 2014.
Find site for bullet 6 circled centre.

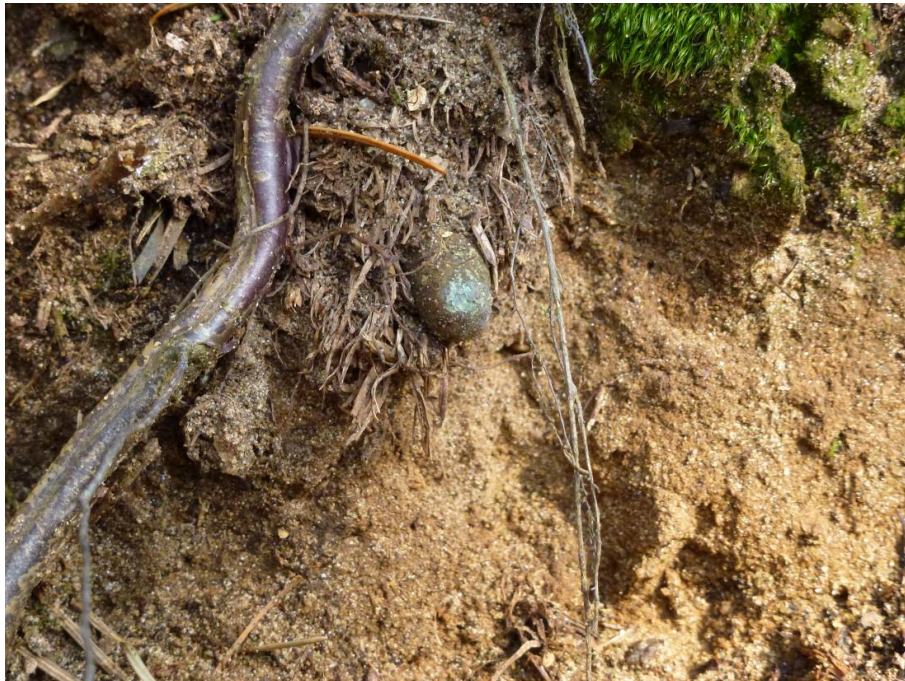
Fig 5.
27th March 2014.
National Grid Reference 25733 94774 Elevation 450 feet
The tip of bullet 6 is seen protruding from the bank. Unlike previous finds, it is possible that this may have been in situ, though it is unusual that the bullet would be facing out of the bank.

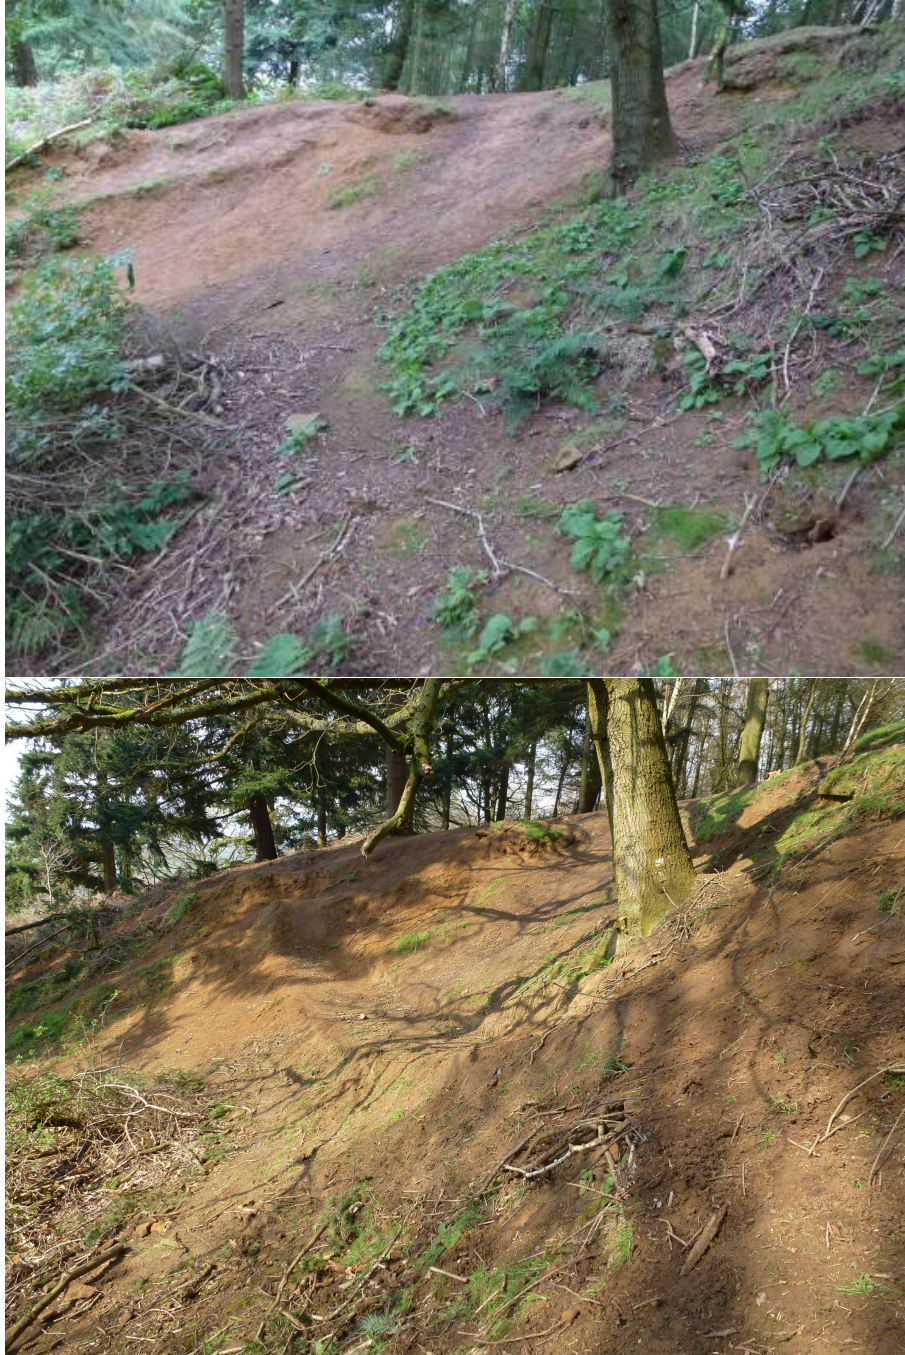
Fig 6.

On the 27th March 2014 visit, extensive excavation of the area of the range by recreational cyclists was noted. This included building a large ramp across one part of the range bank, using excavated sand to build up the area. There was also more extensive animal burrowing visible in the area than on the previous visits. The early 2014 period of extremely heavy rain did not seem to have significantly altered the site.

Comparison photographs, above 16th September 2012, below 27th March 2014.

The lower photo shows a new sand track has been built coming from the bank at the top of the of the range site to the top right of the photograph and crossing below the tree to the opposite side to create a jump. One of the find sites is to the bottom right of the top picture. Some of the metal cable is just visible directly below the tree in the second shot, partially buried by the new material.

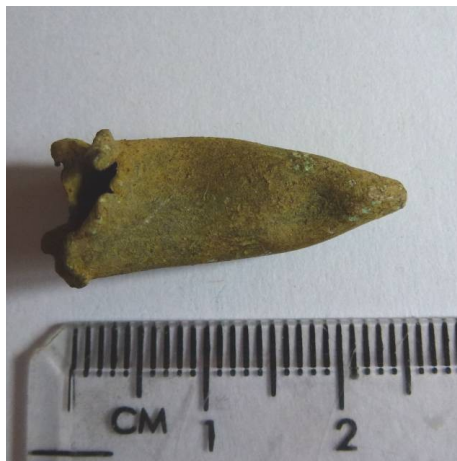
Fig 7.
Bullet 5

This is the tip of a rifle bullet. It is 26mm long and 9.5 mm at its widest (flattened) diameter. It appears to be made of copper and is hollow. These features are typical of British .303 ammunition as used in rifles and other weapons such as the Bren Gun or Vickers machine gun.

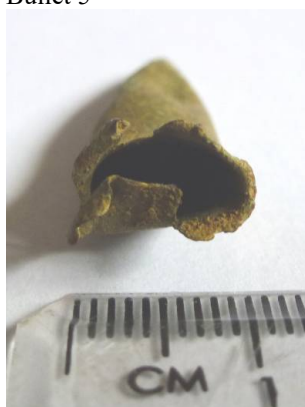
Fig 8.
Bullet 5 showing hollow end.

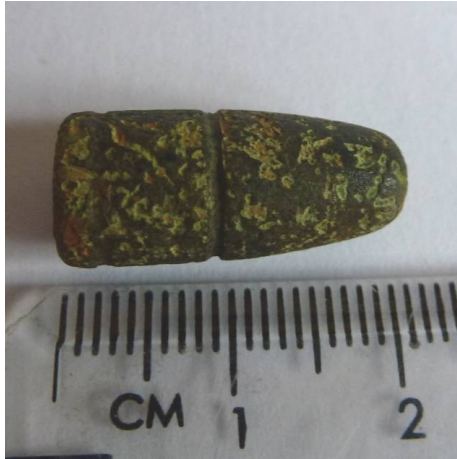
This bullet is exactly 9mm in diameter and 20.06mm long with two recessed bands and an indented base with white colouration within. It appears to have a copper coating in places consistent with a full metal jacket military round. It has not been possible to identify this round, which doesn't appear to be from a Sten gun or to be German 9mm Parabellum ammunition.

Fig 9.
Bullet 6. Two recessed bands in bullet.

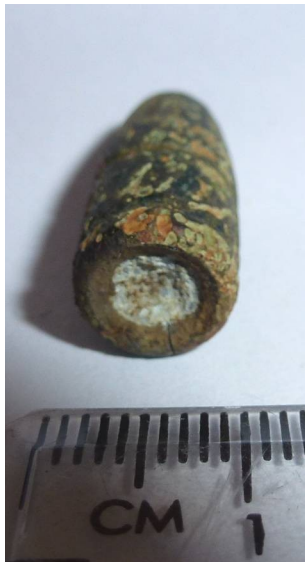
Fig 10.
Base of Bullet 6 showing central white area.
