## **Chichester and District Archaeology Society**

### **Survey and Photographic Record**

#### **Houghton Woods WW2 Auxiliary Unit Hideout June 2019**

**Mike Kallaway and Brian Tomkinson**

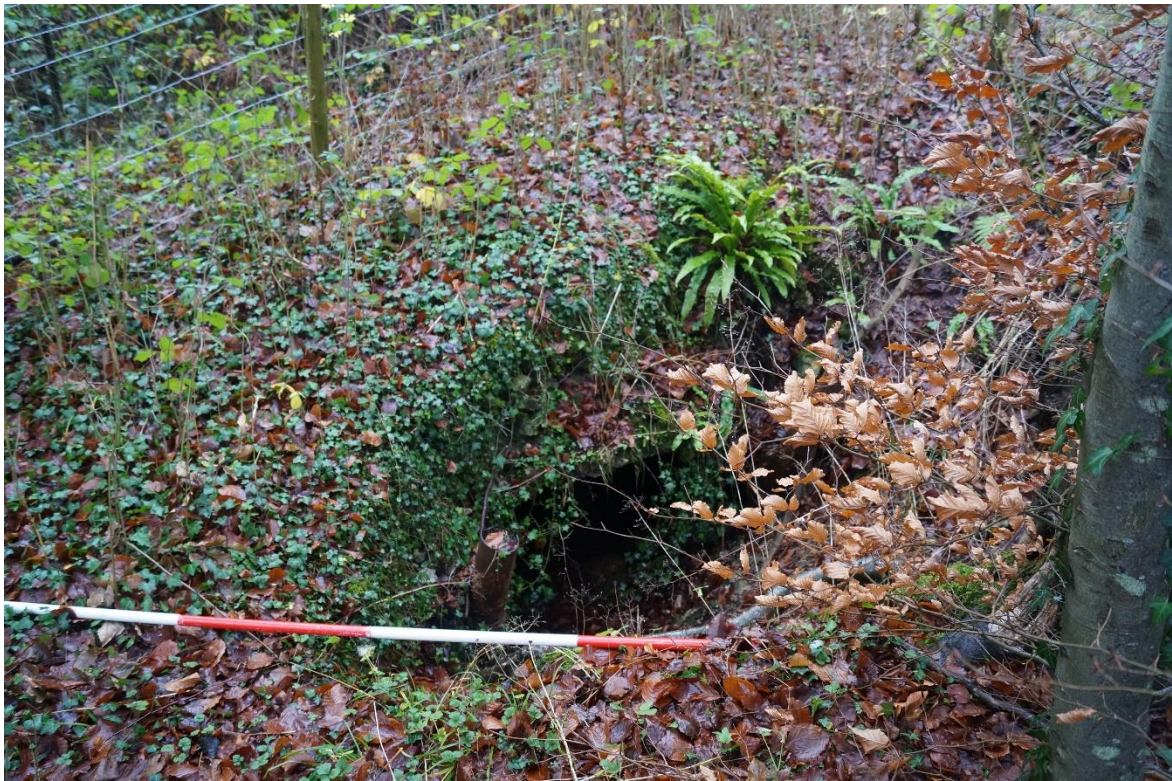
The overall length of the buried structure including a 15m long escape tunnel is around 24 metres. Photographs of the entrance Fig 2 and the end of escape tunnel Fig 3 are shown below. The main entrance is fenced off partly as a safety measure and partly to protect bats which have on occasion been found on the site. Getting into the hideout involves scrambling down the slope taking care not to slip or collide with the corrugated iron roof. The escape tunnel, which is a 15m long concrete pipe, runs in-line with the axis of the hideout. At its far end the tunnel is mostly buried and is extremely difficult to find under the brambles and other vegetation.

Fig 2 Main entrance to the hideout. The leading edge of the corrugated iron roof is visible as are two cast iron ventilation pipes to the left and right of the opening

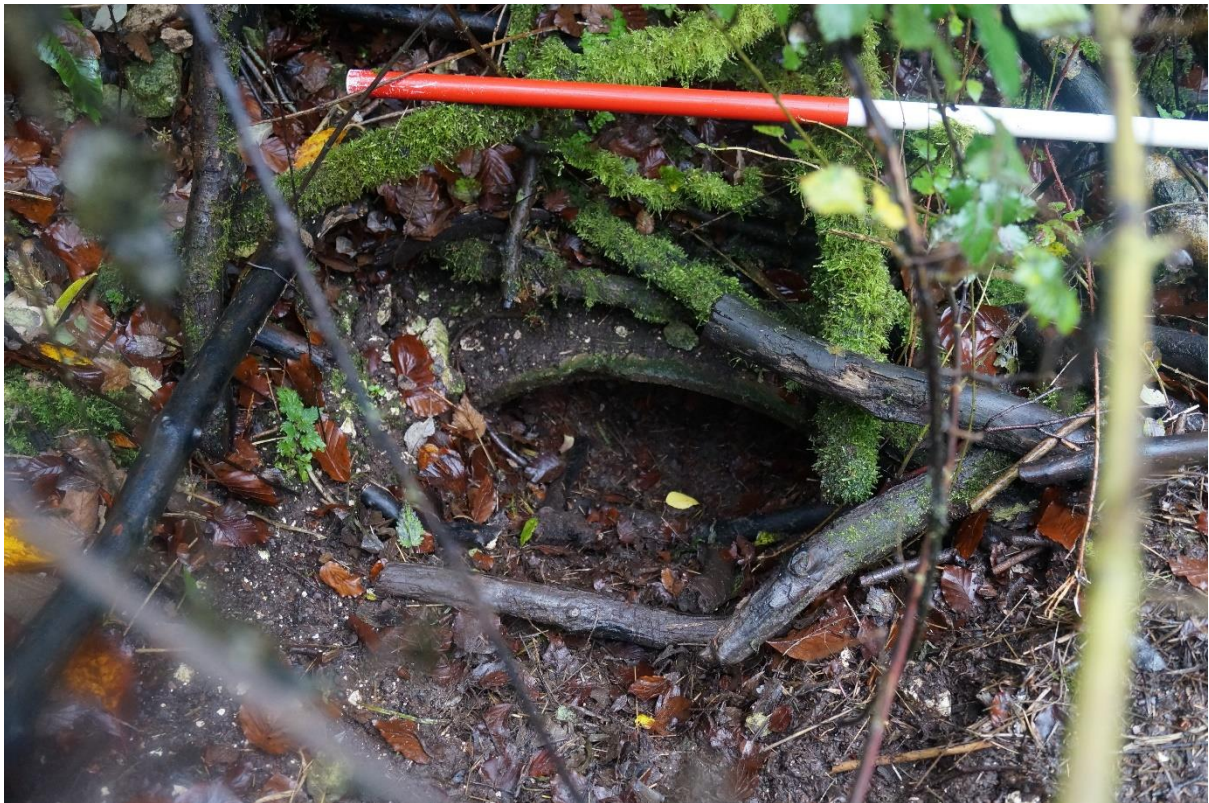
Fig 3 the far end of the Escape Tunnel

The far end of the escape tunnel is partially obscured by soil and vegetation and it can be expected that it will gradually disappear from view. This is not seen as a major issue as it would be relatively easy to locate it and dig it out if ever there were a need for further investigation.

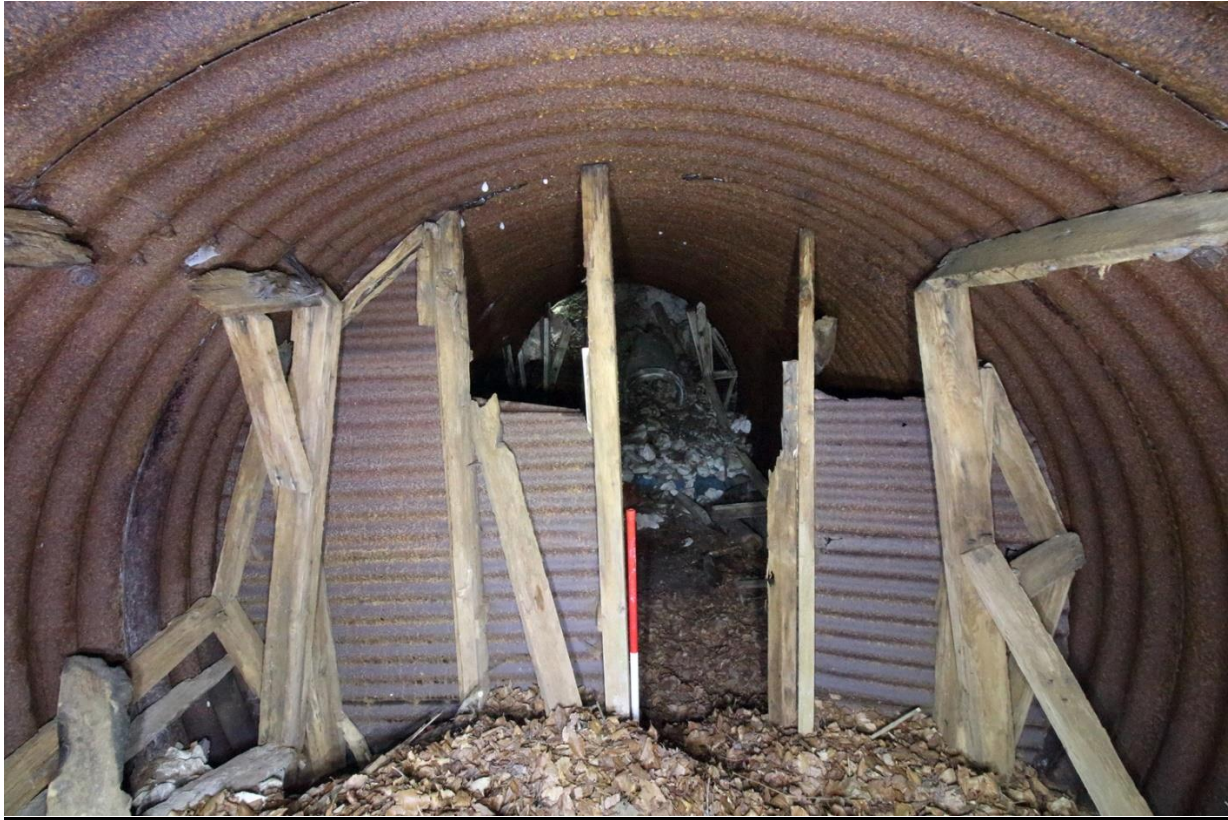
Fig 4 View looking from entrance towards back wall. There would have been a door in the partition but this has been lost

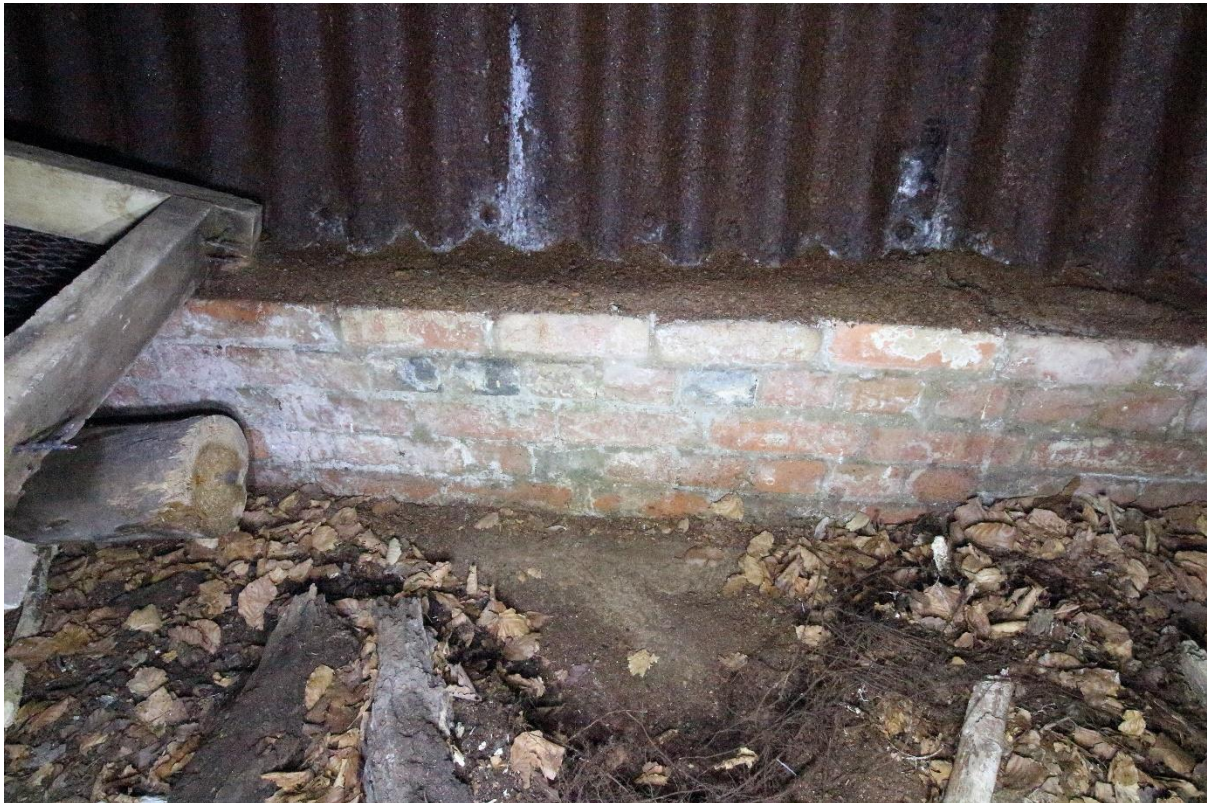
After the trench had been dug, the concrete floor would have been laid and courses of bricks, 5 bricks high, laid along each side (see Figs 9, 11 & 16). The corrugated iron roof would have then been assembled resting on top of the brick walls. This is fabricated from sheets that would have arrived on site, preformed and predrilled in a standard pattern. Three sheets are needed to cover the width of the hideout (see Fig 12). The internal space 3 metres wide and 2.5 metres high creates a comfortable working area

Fig 11 Concrete floor supporting 5 course brick walls and corrugated iron roof

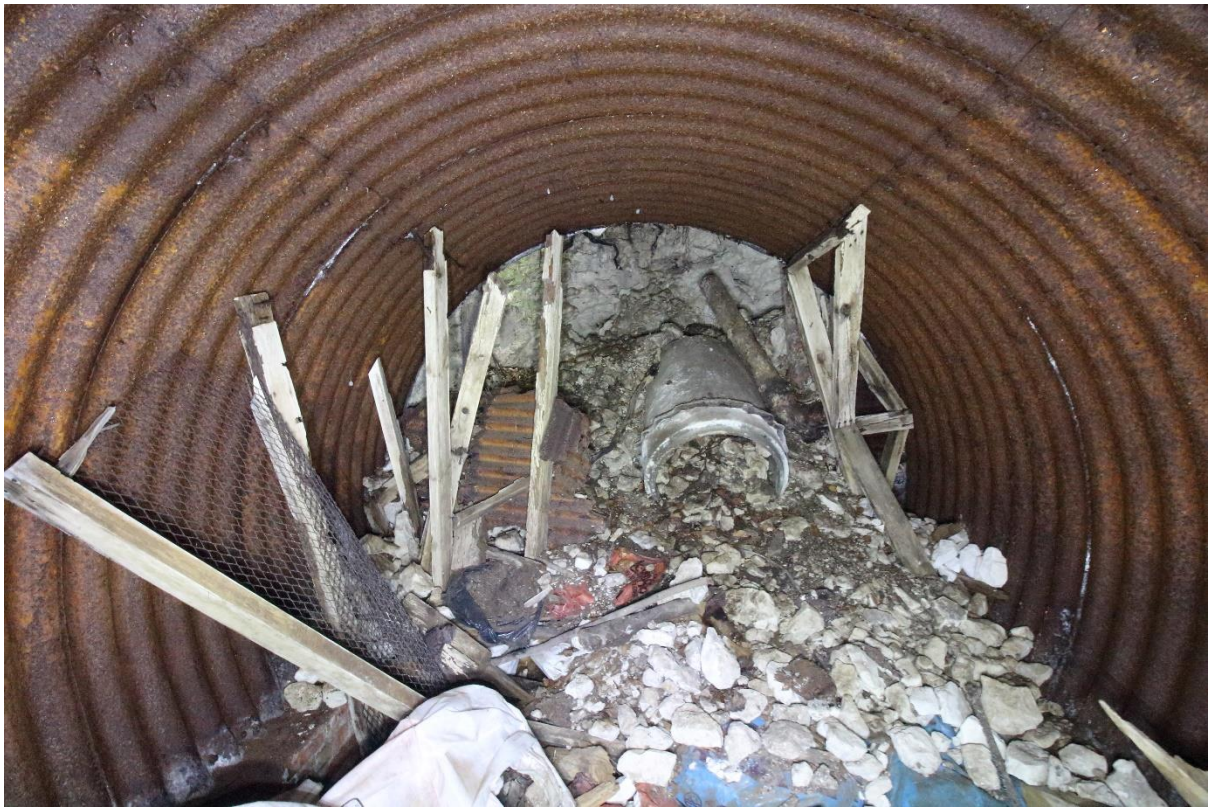
The corrugated iron sheets are bolted together (see Figs 11 & 12) any unused holes are blanked off by bolts. The corrugated iron roof sheets are 2 to 3 mm thick and form a sturdy roof. Looking at Fig 5 the minimum depth of soil above the hideout across the section is 0.7 metres providing good protection.

Fig 12 View towards back wall showing construction with 3 sheets of corrugated iron spanning the hideout and the collapsed section of concrete escape tunnel

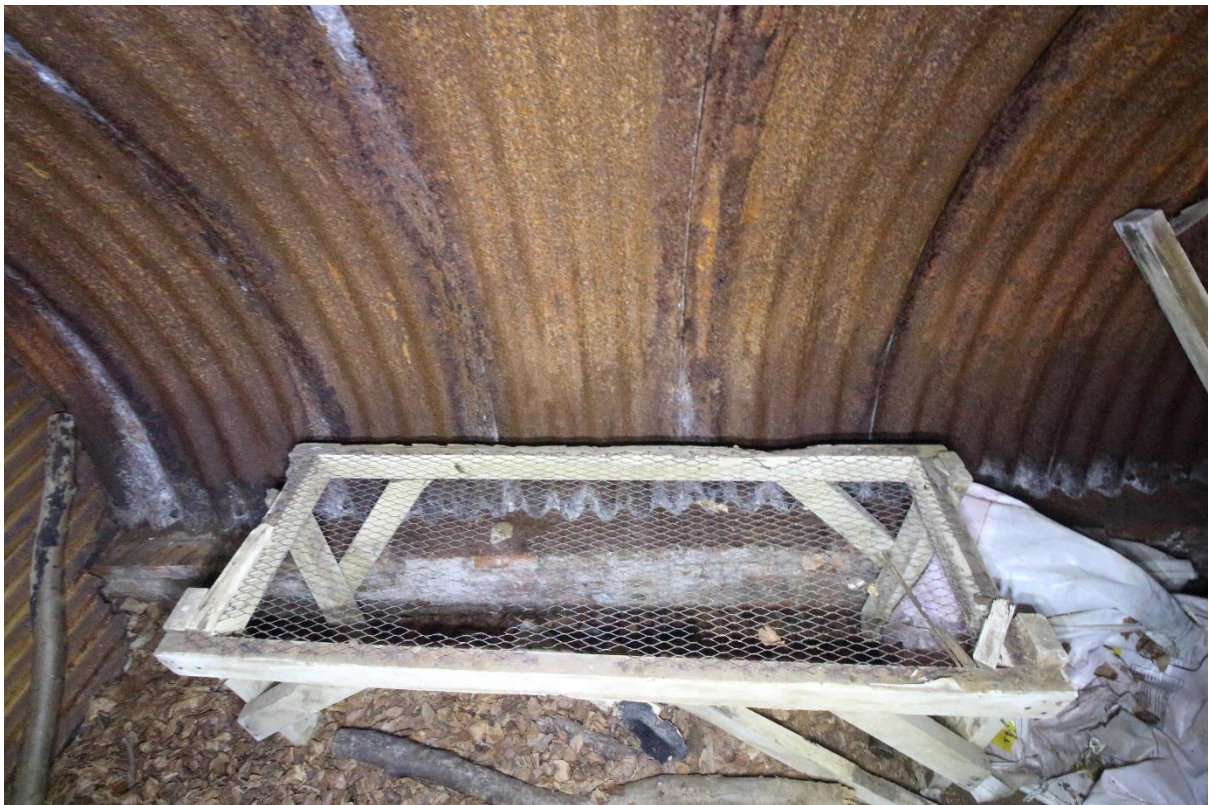
Fig 13 remains of one of the four beds found in the hideout

The beds are similar in design to others we have seen in the Eartham hideout and have been found in other hideouts (ref 4) across Sussex suggesting that they may have been factory made. They have a substantial timber frame covered with wire netting supported on four braced wooden legs.

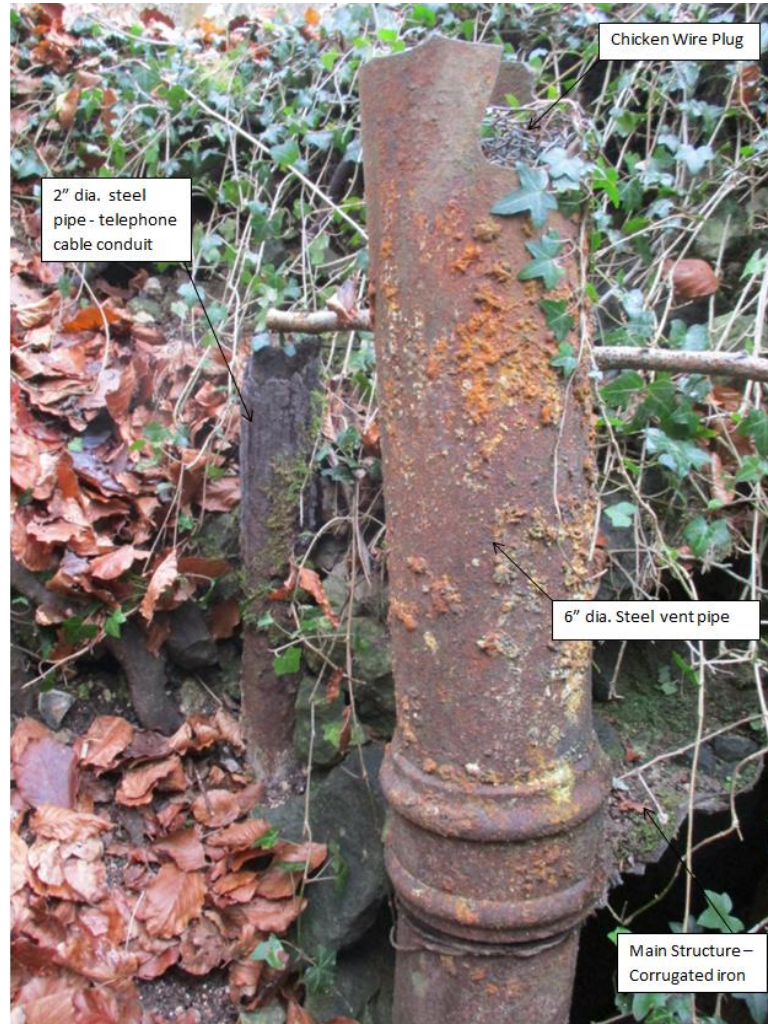
There would have been a telephone cable connecting the hideout to the observation post, probably entering through the 2" steel pipe (Figs 14 & 15) but we did not find it.

Fig 14 – Main entrance showing Ventilation and telephone cable pipes.

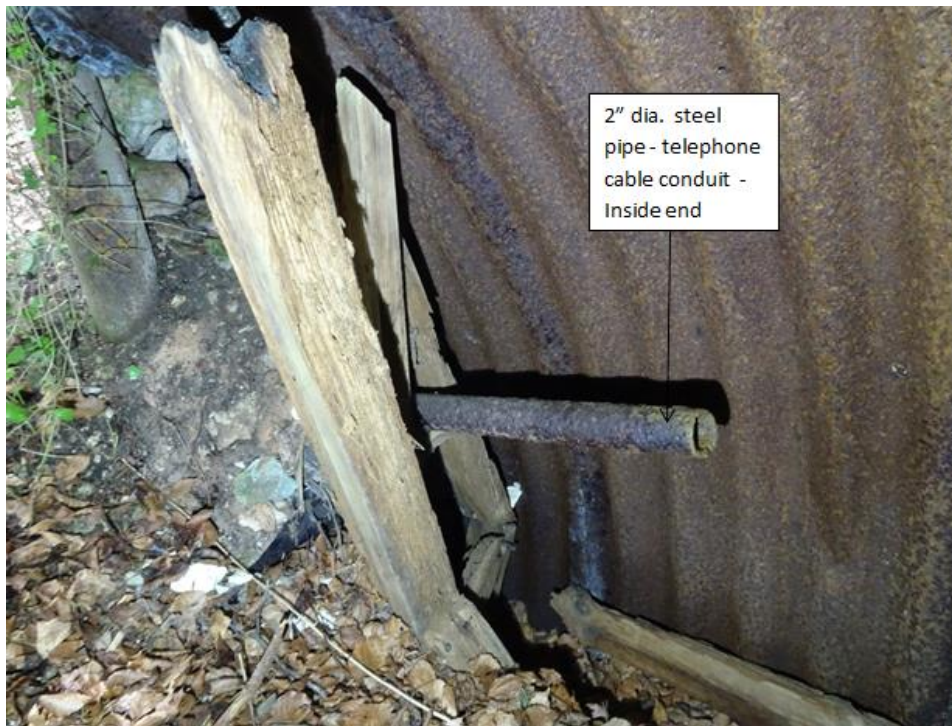
Fig 15 – Telephone cable conduit entry point.

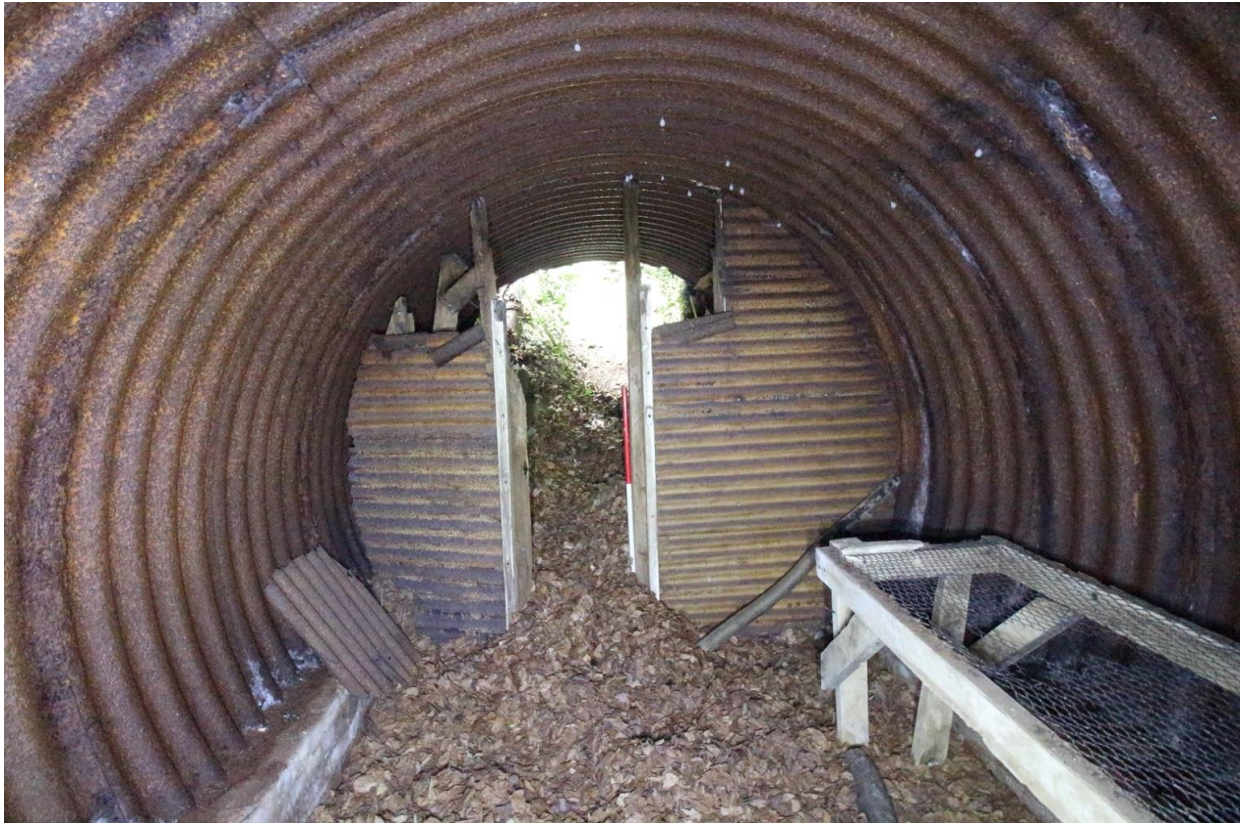
As the trees near the entrance will continue to grow it is anticipated that the entrance will gradually fill-up. The entrance area is fenced off and we do not see this a particular hazard or major cause of concern. Some action to curtail the growth of the trees may be needed at some point.

Fig 16 view from back wall towards entrance showing earth spill into entrance

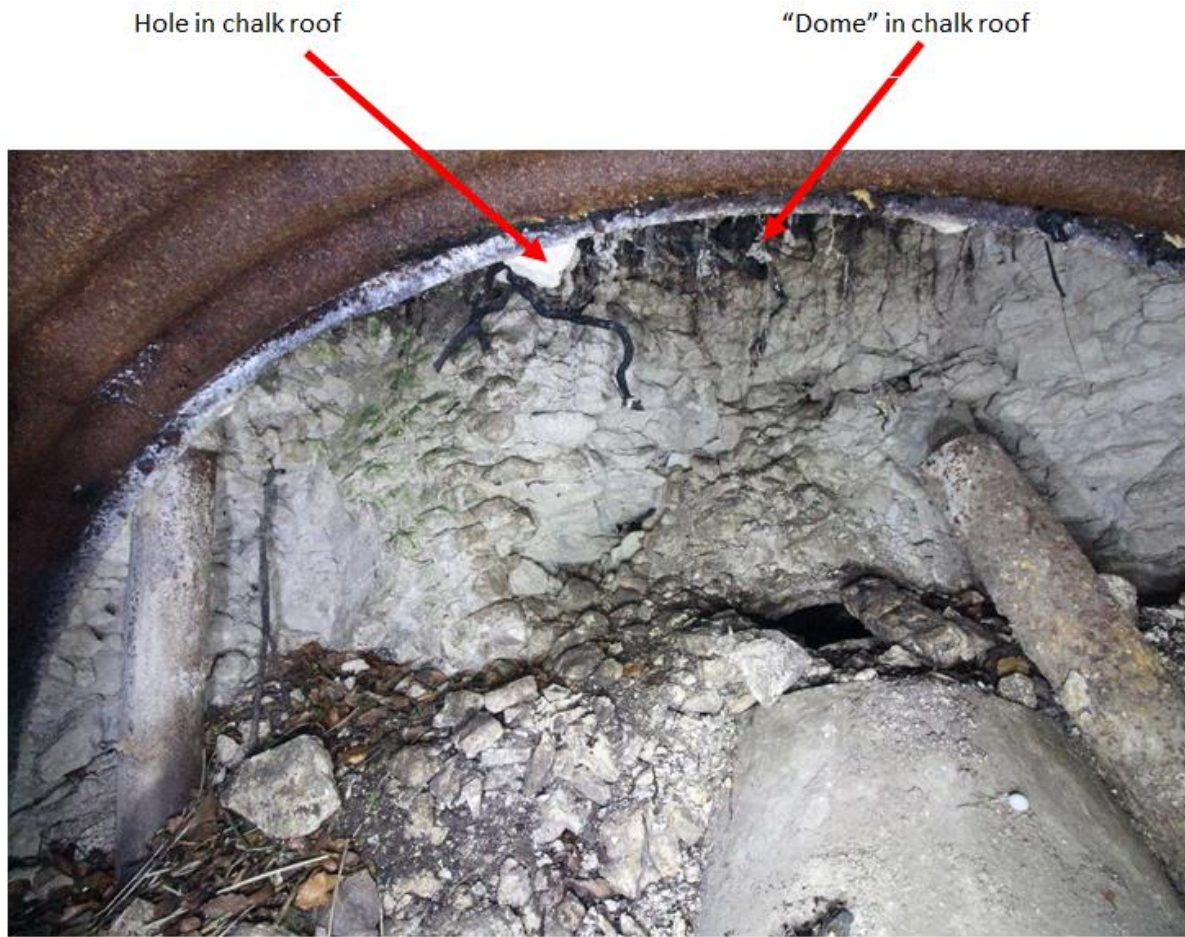
The main concern on the site is the condition of the back wall which has partially collapsed and is at risk of further collapse. Fig 17 shows a close-up view of the back wall above the escape tunnel. There is a small area indicated where the roof has completely collapsed creating a hole in the roof. This was confirmed by putting a ranging pole into the hole from above. There is a risk that someone walking over this part of the site could put their foot down the hole and catch their leg on the edge of the corrugated iron roof below.

To the right of the opening shown in Fig17 there is an area of the chalk roof covering that has partially collapsed creating a “dome”. The thickness of the chalk covering at this point is much less than at other points and is at risk of complete collapse adding to the hazard in this area.

Fig 17 Close up view of back wall showing areas at risk. Also shows two ventilation pipes and two sections of concrete escape tunnel

We do not believe it is practical to shore up this part of the site, fencing it off to prevent access would seem a better solution. It might be best to consider fencing off the whole area from around the main entrance to beyond the back wall.
