## **Chichester and District Archaeology Society**

### **Survey and Photographic Record**

#### **Houghton Woods WW2 Auxiliary Unit Hideout June 2019**

**Mike Kallaway and Brian Tomkinson**

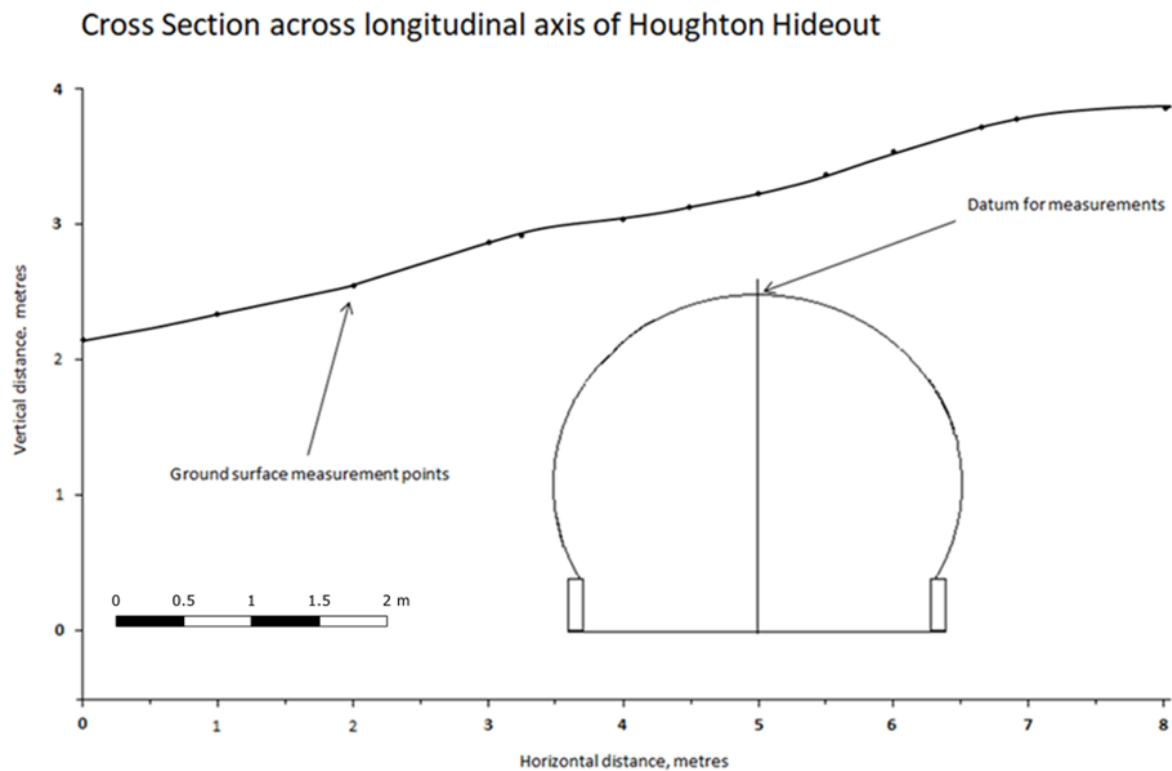
Fig 5 Cross Section across longitudinal axis from topographical measurements.

The corrugated iron sheets are bolted together (see Figs 11 & 12) any unused holes are blanked off by bolts. The corrugated iron roof sheets are 2 to 3 mm thick and form a sturdy roof. Looking at Fig 5 the minimum depth of soil above the hideout across the section is 0.7 metres providing good protection.

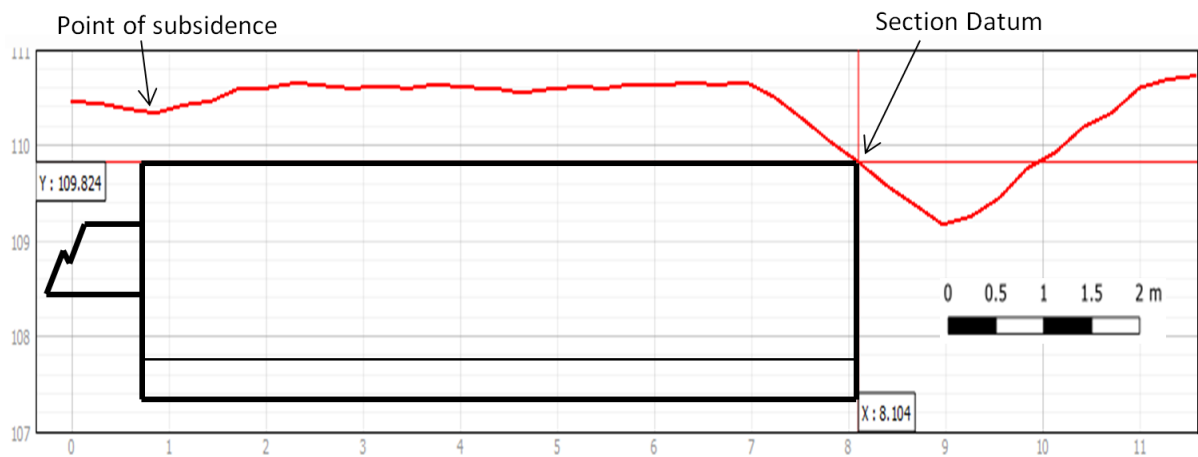
Fig 6. Indicative Cross section along the longitudinal axis of the hideout and part of the escape tunnel.

Due to the density of the overlying vegetation few topographic measurements for the lengthwise or N-S section were able to be made using conventional methods. Those that were made were complimented with data taken from the Secrets of the High Woods LiDAR Survey conducted by the South Downs National Park Authority see Fig 6.

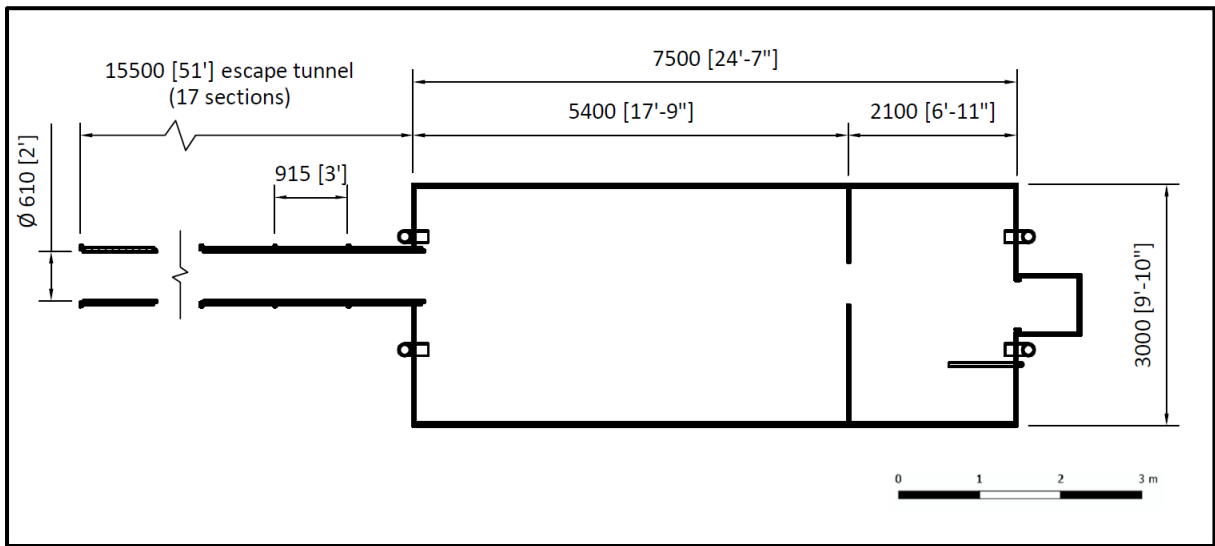
Fig 7 Plan view of hideout \*

Figs 7,8 & 9 show in order, a plan view, a profile along the axis of the hideout and a cross section across the hideout 2.5 metres from the apex of the corrugated iron roof at the entrance. Fig 9 also shows detail of how the supporting walls are thought to be constructed. Fig 10 is an isometric view.

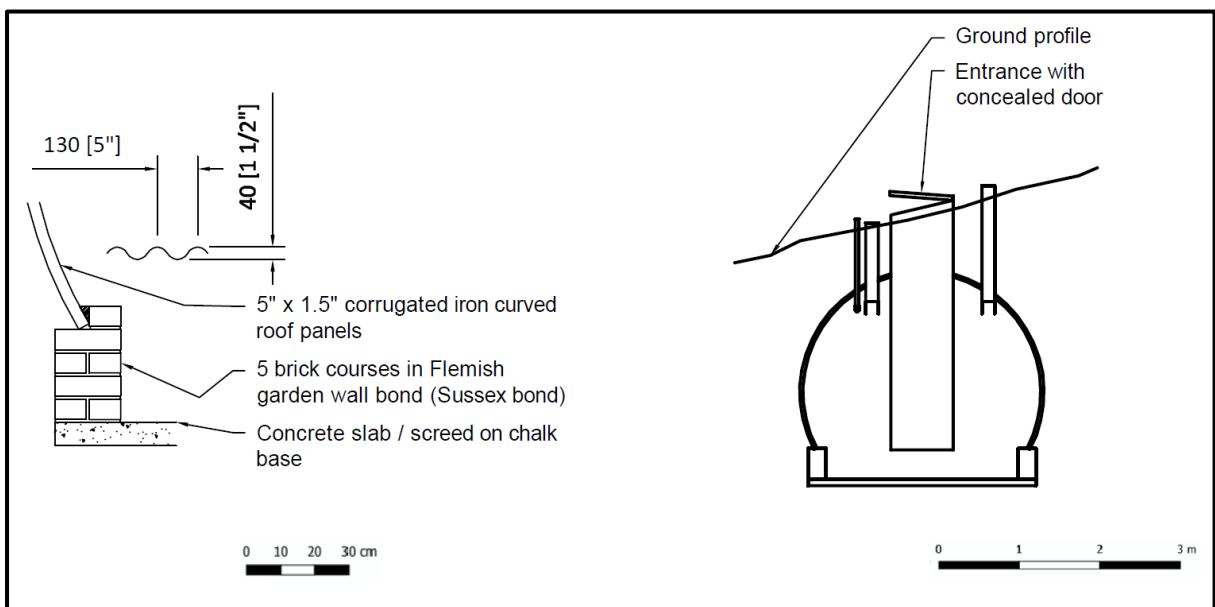
Fig 9 Cross Section of hideout 2.5 metres from entrance showing current ground level \*

After the trench had been dug, the concrete floor would have been laid and courses of bricks, 5 bricks high, laid along each side (see Figs 9, 11 & 16). The corrugated iron roof would have then been assembled resting on top of the brick walls. This is fabricated from sheets that would have arrived on site, preformed and predrilled in a standard pattern. Three sheets are needed to cover the width of the hideout (see Fig 12). The internal space 3 metres wide and 2.5 metres high creates a comfortable working area
