Coleshill Uncovered  
Season 1 fieldwork report  
July 2011

Issue 1.0, January 31<sup>st</sup> 2012

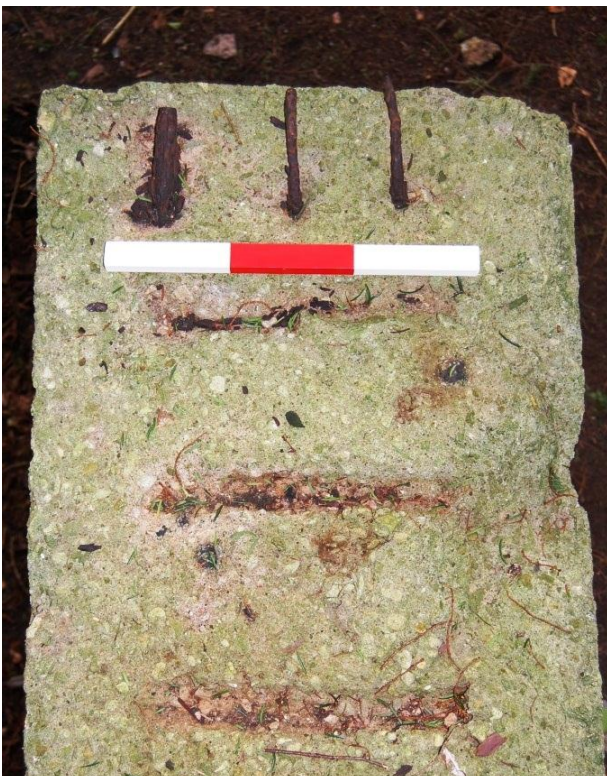
Photo 1: Structure 1 - close-up of reinforcing rods & ridges in concrete, facing south (Photo No. CH07-11-0265)

The plinths were constructed from concrete containing small rounded aggregate (less than 20mm) and horizontal 'pour' lines were visible on the vertical surface. These may be evidence of shuttering that was used as a form for the concrete. A 0.015m layer of ridged concrete (see photo to left) has then been laid on the top of the plinths. At the southern end of the concrete plinths, several steel reinforcing rods (0.03-0.04m long) protruded from the top face of the plinths.

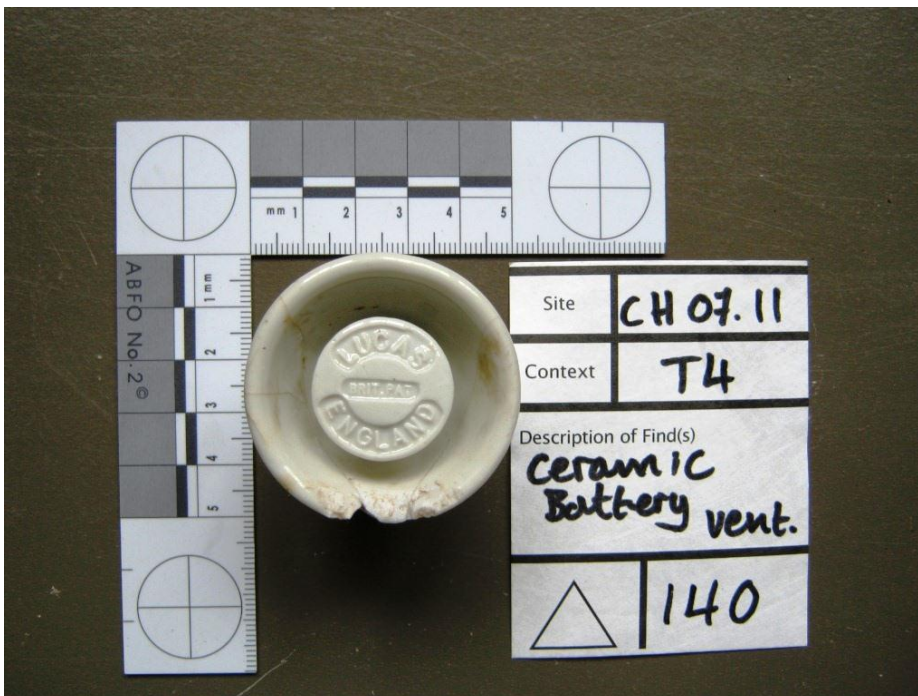
Photo 2: Find 140 – Ceramic battery vent (Photo No. CH07-11- 0168)

- No. 117 - Engine cylinder head gasket fragment.
- No. 118 - Automotive electrical junction box.
- No. 140 - Ceramic vent for a lead-acid vehicle battery, manufactured by Lucas.
- No. 138 - Part of a clear glass lens, possibly from an airfield runway light (maybe attributable to the Auxiliaries).

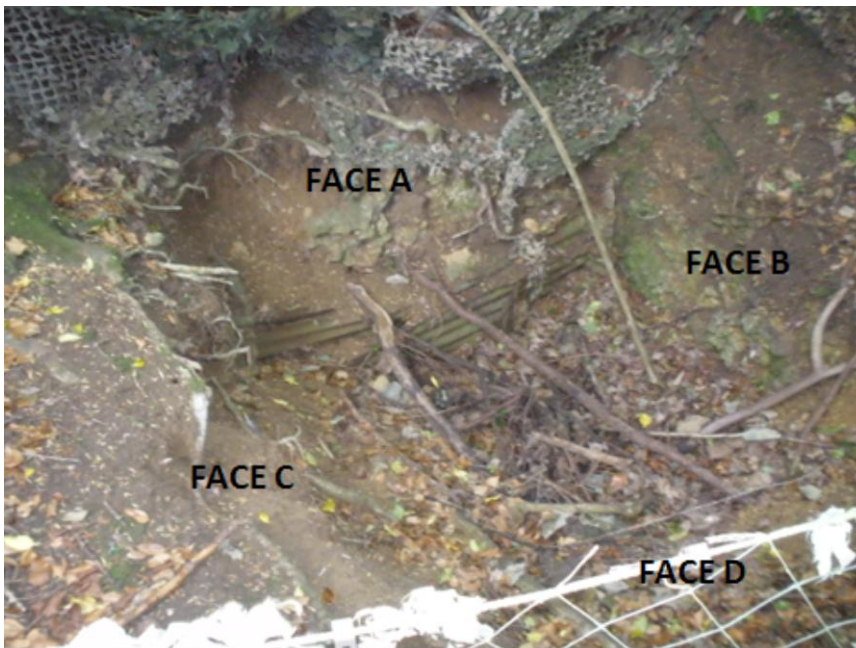
Photo 3: Structure 3 – general view

The feature known as the 'Ammo dump' is a large pit in the ground, approximately 2.5m wide by 3.5m long by 2.5m deep, with the long sides facing north and south. The pit has near vertical sides on Faces A, B and C, whilst Face D tapers up to ground level at an approximate angle of 45 degrees, permitting access (see photo overleaf). Two large trees sit close to the corners of Faces A-B and A- C with their root systems protruding from the faces. The ground structure appears to consist of 0.5m of soil overlying weathered stone. Sheets of 'wriggly tin' are visible at the base of Face A, although it is unknown if those are contemporary with the construction of the pit or later additions. The bottom of the pit contains some soil infill, leaves, branches and other general detritus. Some rotten plywood boarding has also been noted laid horizontally at the bottom, perhaps in a previous attempt to prevent infill of features below this. The deteriorated remains of modern camouflage netting are visible in places on Face A.

The pit has been partially excavated at some point and items of Nissen Hut furniture (stove pipes etc.) have been recovered. This suggests that the pit has at some point been used as a convenient place to dispose of demolition debris from the site. It is likely therefore that other items found on the site (including munitions) that required quick disposal may have been thrown into the pit (indeed this may be the reason why the pit has become known as the 'Ammo Dump' as opposed to any actual original use as a place to store munitions).

The pit is currently in a stable condition with the root systems of the trees acting as a living framework to prevent significant collapse of Face A. The top lips of Faces B and C have already been slightly cut back by natural weathering. Surface clearance of the detritus from the pit floor to ascertain exactly what detailed excavation may or may not be necessary could be undertaken safely, without any risk of collapse, by a team consisting of two people (no more and two required for mutual safety) wearing safety helmets and lines. The tops of Faces B and C could be further cut back to prevent any risk of top collapse from these sides if required. The most dangerous side is Face A and whilst 'cutback' of the top lip is advisable in most cases it is not recommended here as this would interfere with the tree root systems that are currently helping to stabilize that side and would probably cause instability rather than helping to stop any possible collapse. An area 2m around the top of the pit would need to be marked off as an exclusion zone to prevent 'kick-in' of material onto the heads of those working in the pit. If any further excavation other than preliminary surface clearance is required then it is recommended that Face A be shored up with a sheet of heavy duty plywood, braced back into the slope of Face D. Any work within the pit would require a surface supervisor in addition to the two diggers and the presence of a qualified Explosive Ordnance Disposal person. The cutting of steps into Face D to aid entry and exit is recommended

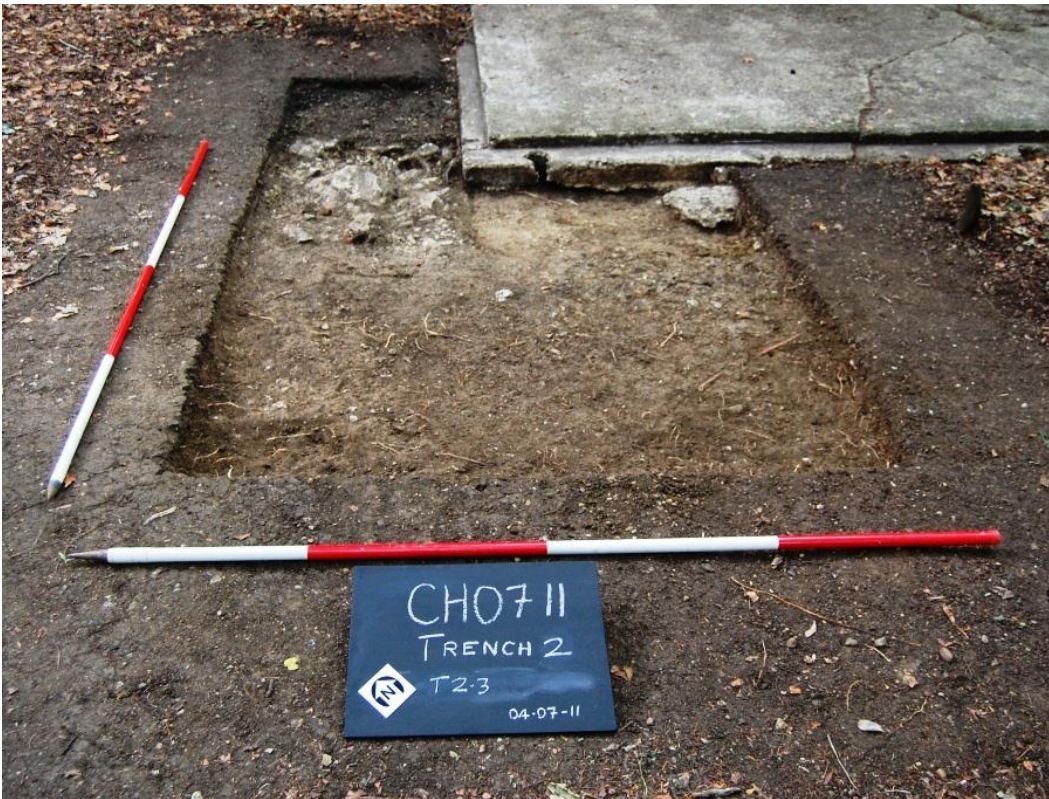
Photo 4: Trench 2 – view of completed trench, facing north-east (Photo No. CH-07-11-0014)

Starting up against the western side of the concrete base, the compacted gravel layer was removed to reveal a layer of hard core rubble (2.3). Ranging in size from 0.05m to 0.20m across, this hard core abuts the concrete base and continues for approximately 0.50m to the west. It is believed that this rubble has been used as backfill to fill up the shallow depression cut into the ground for the concrete base to be laid into. The gravel has then been laid on top and compacted down to create a flat surface to walk on outside the building.

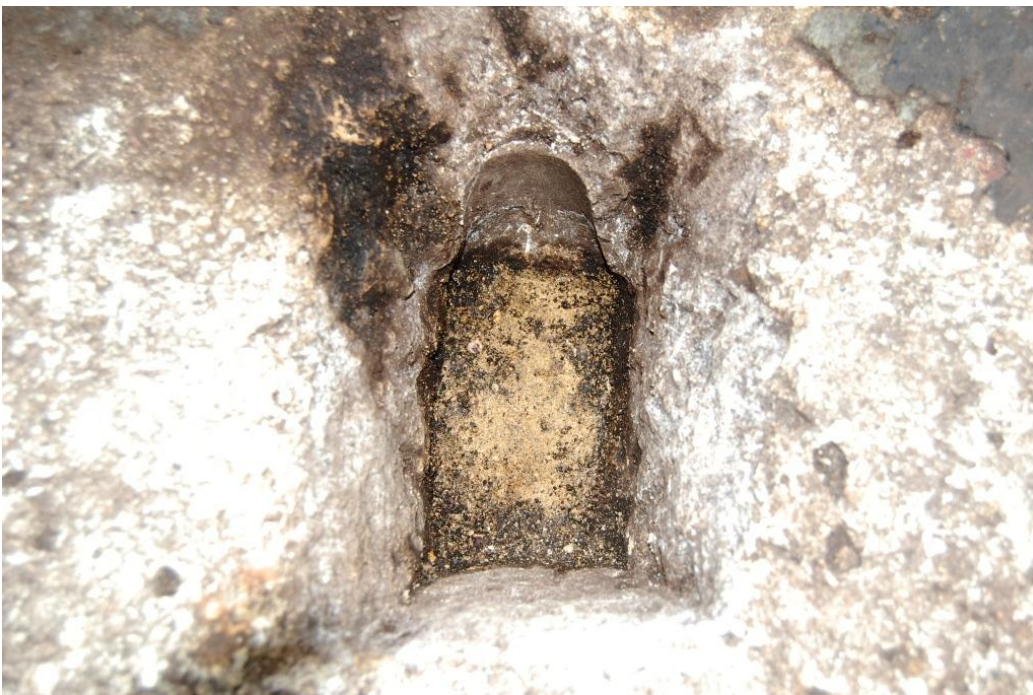
Photo 5: Structure 6 - southern edge, Post hole 2 (Photo No. CH07-11-0117)

The rectangular post holes that had been noted in January and were located on the southern edge of the platform were investigated further. The second hole from the east corner (post hole 2) was measured and found to be 0.16m east-to-west and 0.23m north-to-south. The sides of the hole sloped inwards to a depth of 0.11m and the dimensions at the bottom were 0.065m east-to-west

and 0.11m north-to-south. On its' southern side at the bottom there was a semi-circular niche, 0.085m across. It appears that the holes were cut through the concrete down onto a hard sandy layer. It is possible that this sandy layer was laid down as a levelling layer prior to the concrete being poured. The post holes, which sat approximately 2.28m apart, were not uniform in size and shape (some sloped more than others). This, along with chisel marks inside one of the holes is evidence that they were handmade after the platform had been poured. The second hole contained traces of metal in the semi-circular niche. Was this a pin to wedge a wooden post in place in the main part of the post hole? On the northern edge of the platform four post holes were uncovered (the final two being underneath the vegetation that was not removed), all were located directly opposite a post hole on the southern edge.

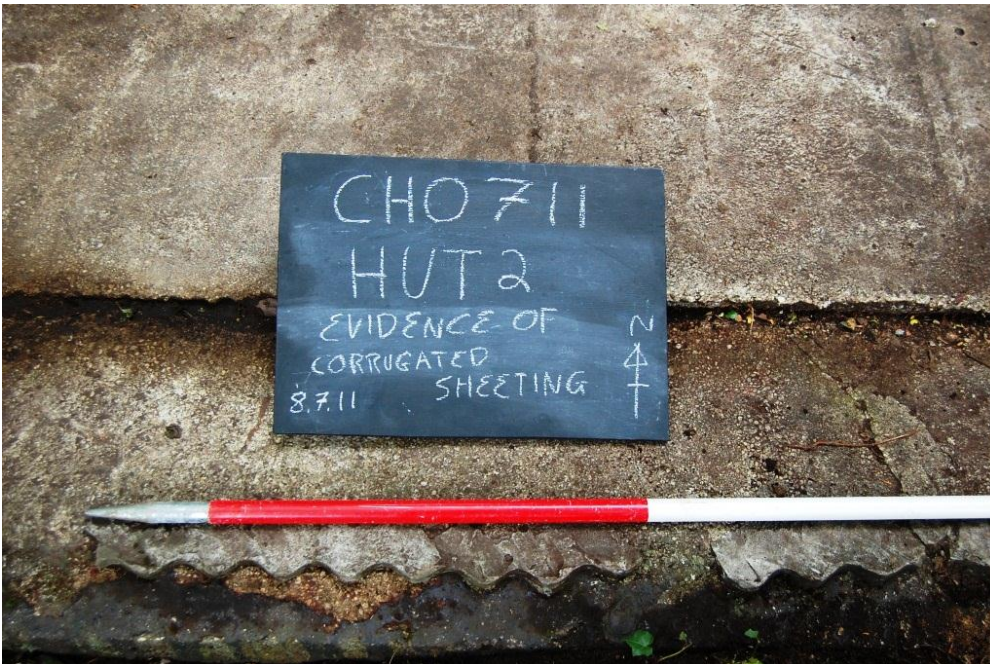
Photo 6: Structure 6 – evidence of corrugated sheeting & bitumen (Photo No. CH07-11-0128)

The March Interim Report noted evidence of corrugated metal having been used as part of the building construction. These 'wiggly' markings in the concrete are located on both the northern and southern long sides of the platform and it is likely that the metal sheets were supported by the posts located in the six post holes that run along these lengths. In all locations where the 'wiggly' lines are situated there are also drips of bitumen (see photo on next page), suggesting that this was used to seal the bottom of the metal walls to protect the building from damp. In places the bitumen runs over patches of white and red paint. Was the outside of the building painted?

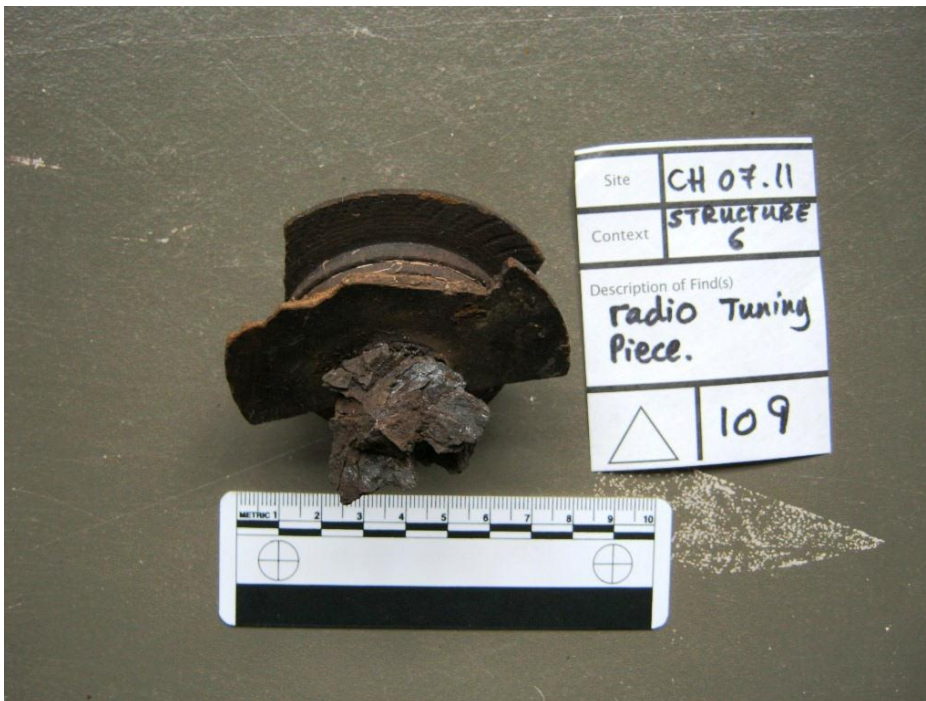
Photo 7: Find 109 – radio tuning piece (Photo No. CH07-11-0146)

A lot of good structural evidence from concrete to electrical fittings from both the clearance of this structure and from piles located close-by were collected. Of special interest is Find No.109 - internal string spool for the frequency display from the tuning dial of a civilian radio. It was likely discarded as not required in the military radio being built from recycled civilian parts. (An exterior 'Treble' knob was also found at Structure 1 = Trench 4 (Find No.120)).

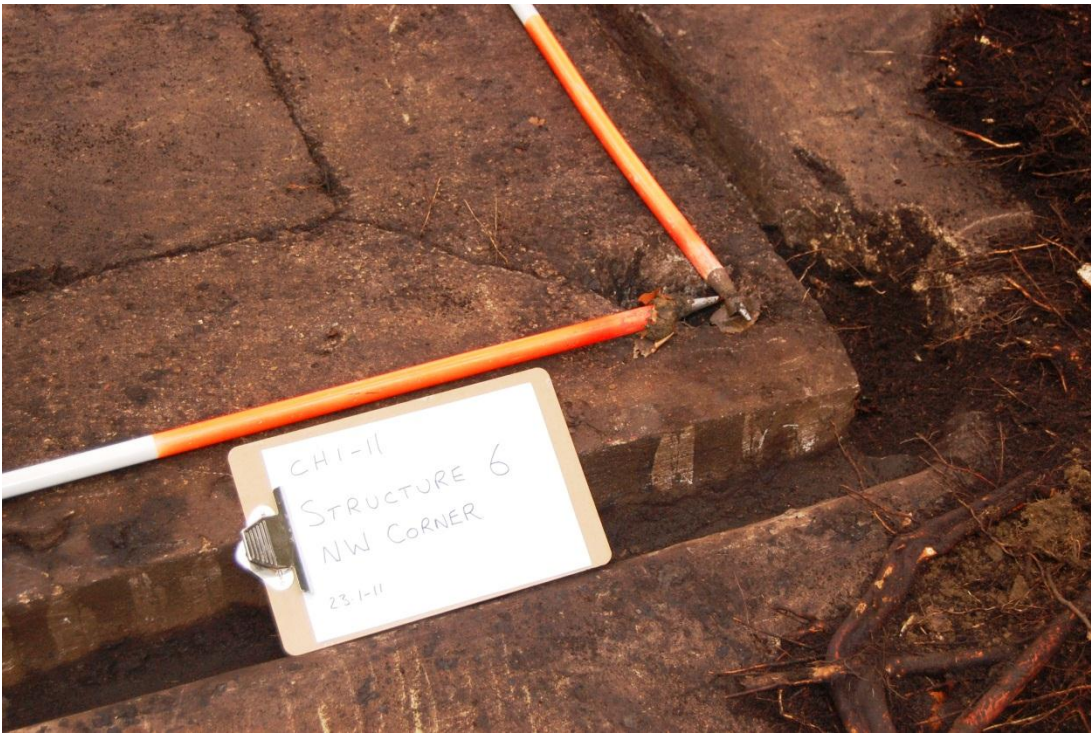
Photo 8: Structure 6 – crack around concrete base, NW corner (Photo No. CH1-11-0022)

It is possible that the large crack around the main part of the platform is in fact from where the concrete was poured in two sections (see photograph on next page). The outer section (which includes the gully and outer pathway) may have been poured first, with the inner larger section being poured in afterwards.

Approximately 0.50m in from the edge of the main platform there is a crack in the concrete. This was noted in January, but now that the majority of the platform has been cleared it can be seen that this crack runs all the way around the platform at about the same distance on all four sides. The concrete gully that runs around the outside of the structure was cleaned further and its dimensions can now be seen clearer than when it was initially looked at in January. The north-east corner was reviewed and the gully (which is wider at the top than it is at the bottom) is 0.10m at the top and 0.05m at the bottom. It was also found to sit at slightly different heights below the level of the concrete platform and pathway on the northern and eastern sides. On the northern side the gully sits 0.12m below the level of the concrete platform and 0.036m below the level of the outer pathway. On the eastern side it sits 0.17m below the level of the concrete platform and 0.07m below the level of the outer pathway. The north and south sides show that the gully may have been painted with bitumen, however it is more likely that these patches are run-off from sealing the edges of the metal sheets.

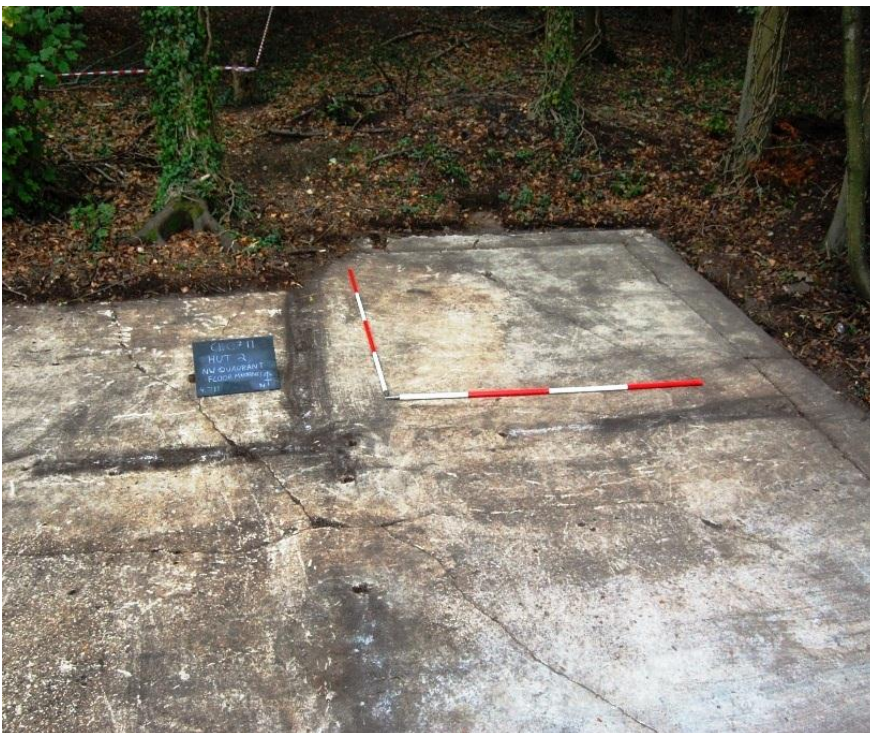
Photo 9: Structure 6 – white marks believed to be location of internal walls, facing north (Photo No. CH07-11-0022)

Believed to be remains of concrete, the white lines are thought to represent the internal walls of the building. The gaps would therefore show the positions of doors, with the depressions being where the door frames were fixed into the concrete, possibly via Find No's 338 and 339. In this way we can now see much of the internal arrangement of the building (see Drawing No. 9 in Appendix A). All internal walls appear to have been approximately 0.10m thick.

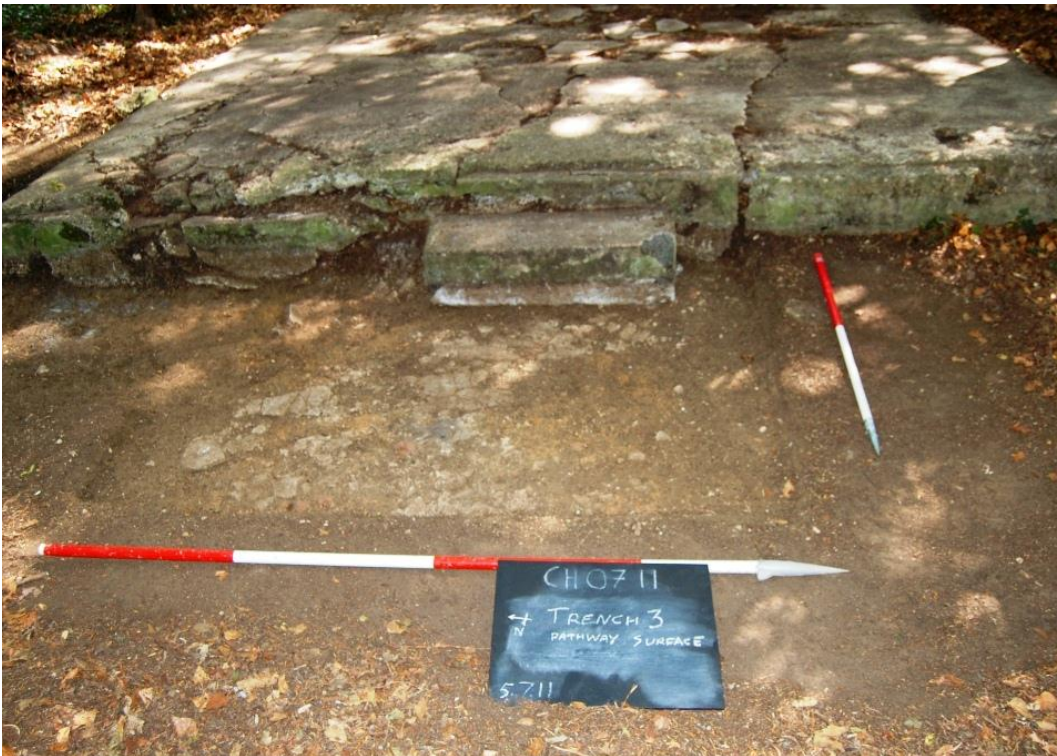
Photo 11: Structure 7 – evidence of pathway, facing east (Photo No. CH07-11-0028)

After a depth of 0.05m an area of concrete (3.2) was uncovered. Located outside the structure doorway (represented by a concrete step up to the platform) this concrete was only 0.02m - 0.03m thick. Badly broken up and overlying a thin levelling layer of sandy gravel (3.4), the concrete continued beyond the limit of excavation to the west. Trench 3 was therefore extended by 0.5m to the west. More of the thin concrete layer was uncovered running in the direction of Structure 5. It is believed that the concrete layer represents the remains of pathways (see photograph on next page).

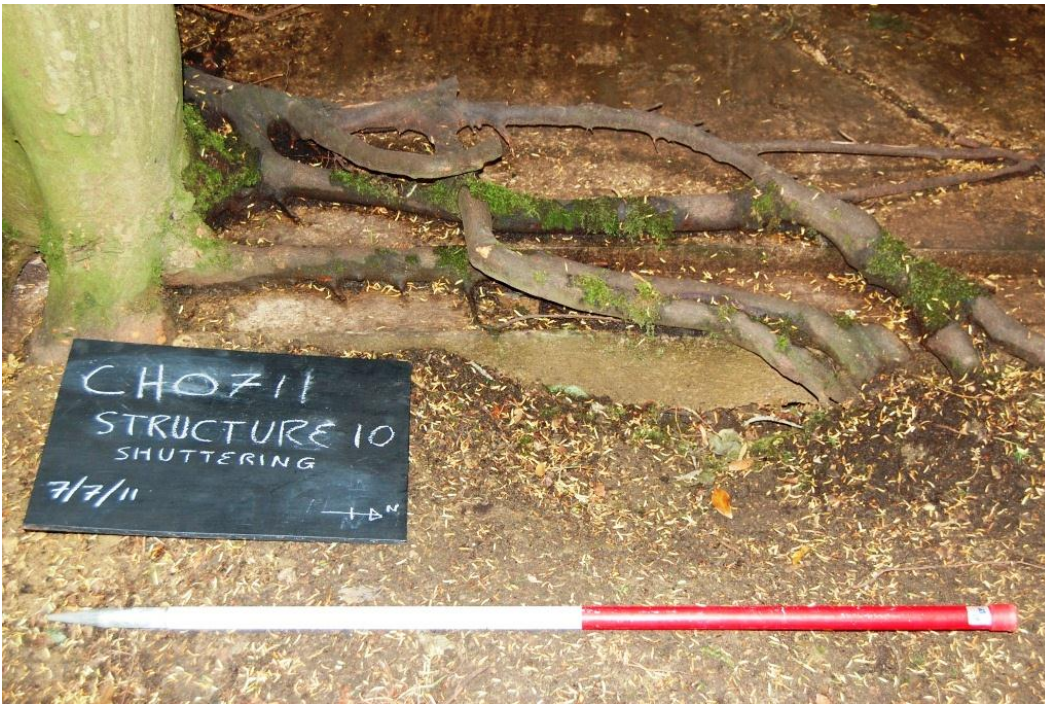
Photo 13: Structure 10 – In-situ shuttering (Photo No. CH07-11-0090)

Half-way along the eastern side of the concrete base there is a single piece of in-situ shuttering, possibly asbestos board (see photograph on next page). On the top face of the concrete base, towards its' western side, are the casts of inverted bricks.

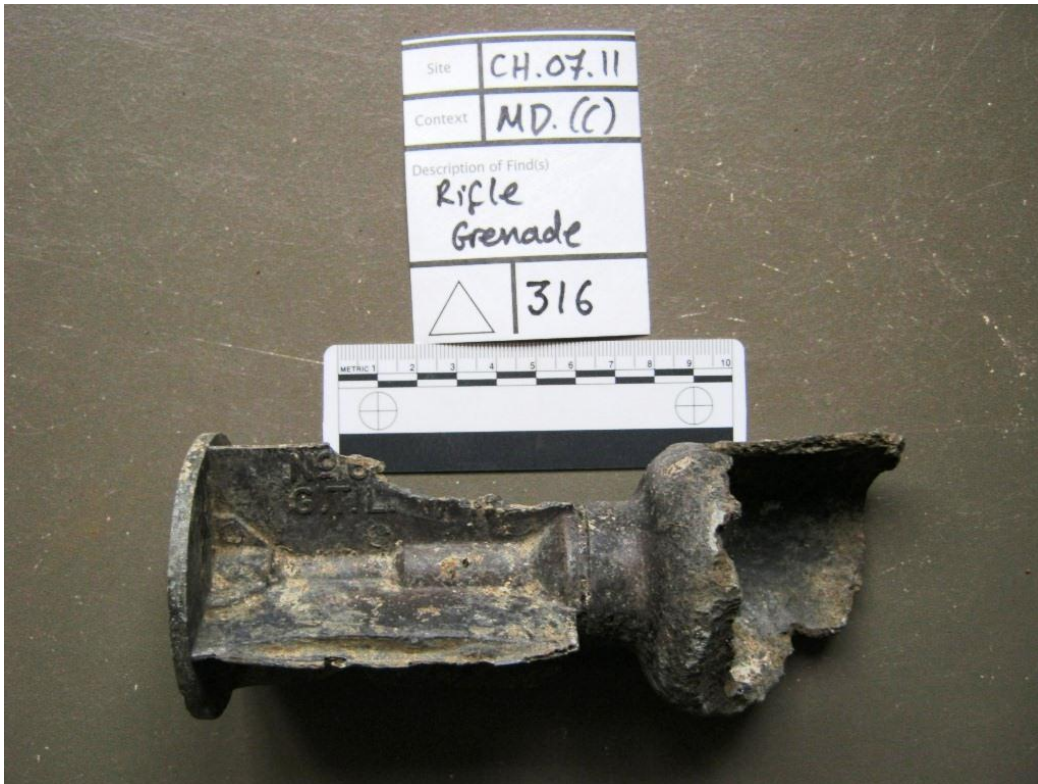
Photo 14: Find 316 – rifle grenade (Photo No. CH07-11-0241)

- No. 316 - A No. 68 Mk (3/4/5/6?) High Explosive Anti-Tank (HEAT) grenade manufactured by "GTL". For firing from a Cup launcher attached to a 0.303 Lee Enfield rifle, or from a Northover Projector. (See photograph on next page).

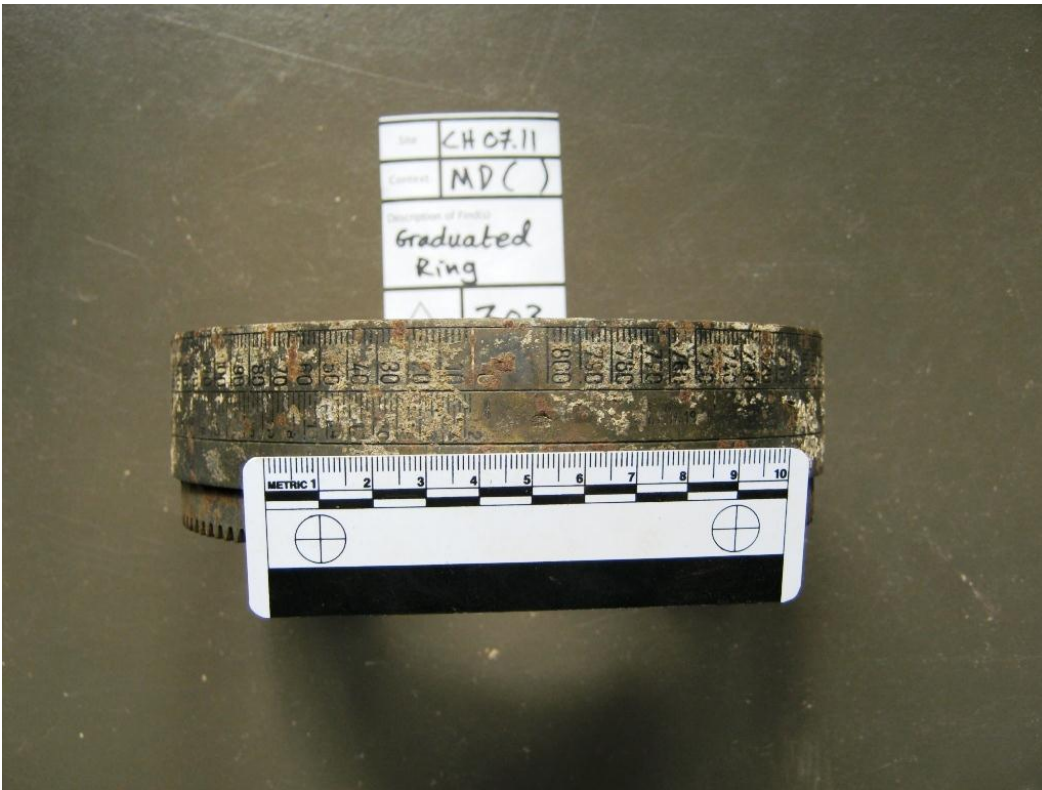
Photo 15: Find 303 – range drum graduated ring (Photo No. CH07-11-0240)

- No. 303 - The range drum from the sight on a German 105mm leichte FeldHaubitze 18 (=light field howitzer) – see photograph on next page. Two office markings have been deciphered; manufactured by the Spandau factory between 1932 and 1938. There may be a Finnish connection with this item and the Mauser cartridges from the January MD survey (Find No.9)

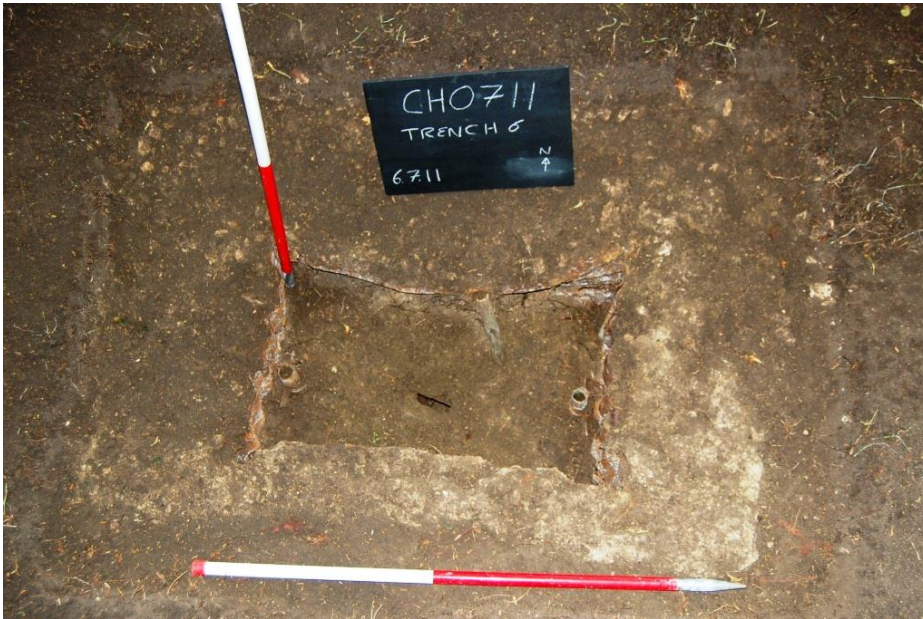
Photo 16: Trench 6 – facing north  
(Photo No. CH07-11-0046)

Orientated north to south with its' two long sides facing north and south, this rectangular hole was 0.80m by 0.50m – see drawing no. 5 in Appendix A. The full extent of the concrete surround was never fully revealed, but was at least 1.30m square, with the feature sitting towards its' south-east corner. The hollow centre of the feature, that suggests it may be a shaft or entranceway of some kind, was full of a rich black organic soil (6.4). Clearing this fill revealed that the corrugated sheets had been placed vertically on the east and west sides, but horizontally on the north and south. Both of the horizontally placed sheets had folded over on the top as a partial collapse, presumably when rubble was thrown into the feature at the end of its' useful life.

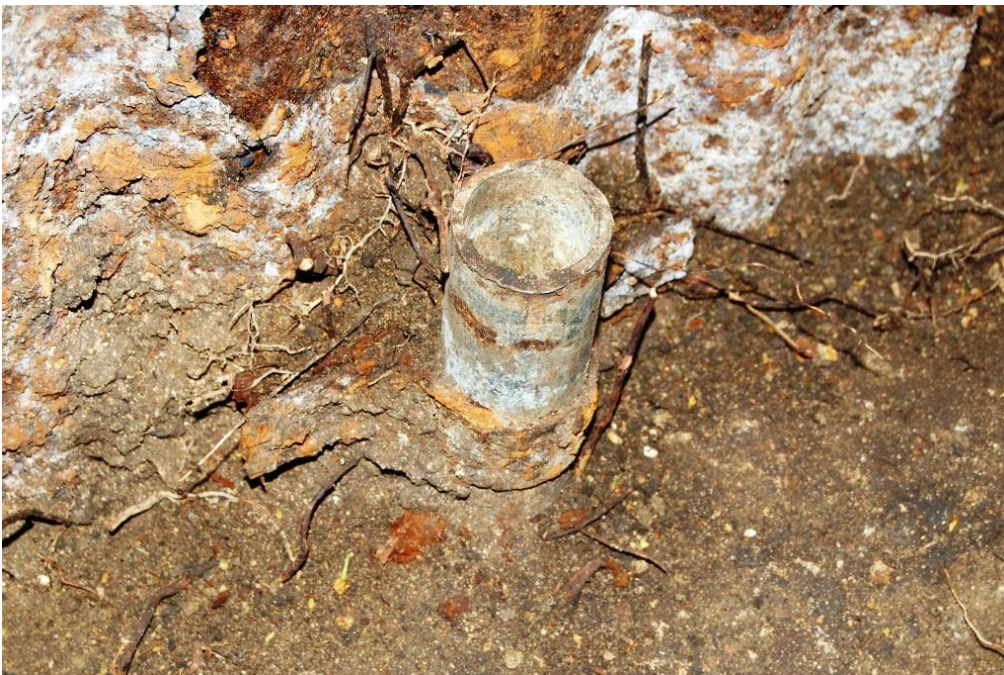
Photo 17: Trench 6 – metal pipe attached to corrugated iron by C bracket (Photo No. CH07-11-0051)

On the east face of the feature a hollow metal pipe was attached by a bracket to the face of the tin sheeting (see photograph below). Another was revealed opposite on the west face. The fill was

removed to a depth of 0.30m whereupon a reasonably compacted layer of concrete rubble filled the feature. Two hollow pipes were also set within the concrete which seals the possible shaft. These appear to be of a diameter that allowed them to fit inside the hollow tubes that are bracketed to the west and east faces of the feature. Cleaning the concrete within the shaft revealed a small void. One of the project EOD officers took a look inside this void and determined that at this time it was unsafe to continue. Digging in Trench 6 stopped at this point, with the feature being cleaned up, photographed and planned.

a system involving pulleys and weights. The hollow pipes found clamped to the east and west faces of the feature seem to be in-situ parts of this counterweight mechanism. It also appears that once the 'useful life' of the feature ended broken up concrete rubble was thrown into the shaft to seal it up.

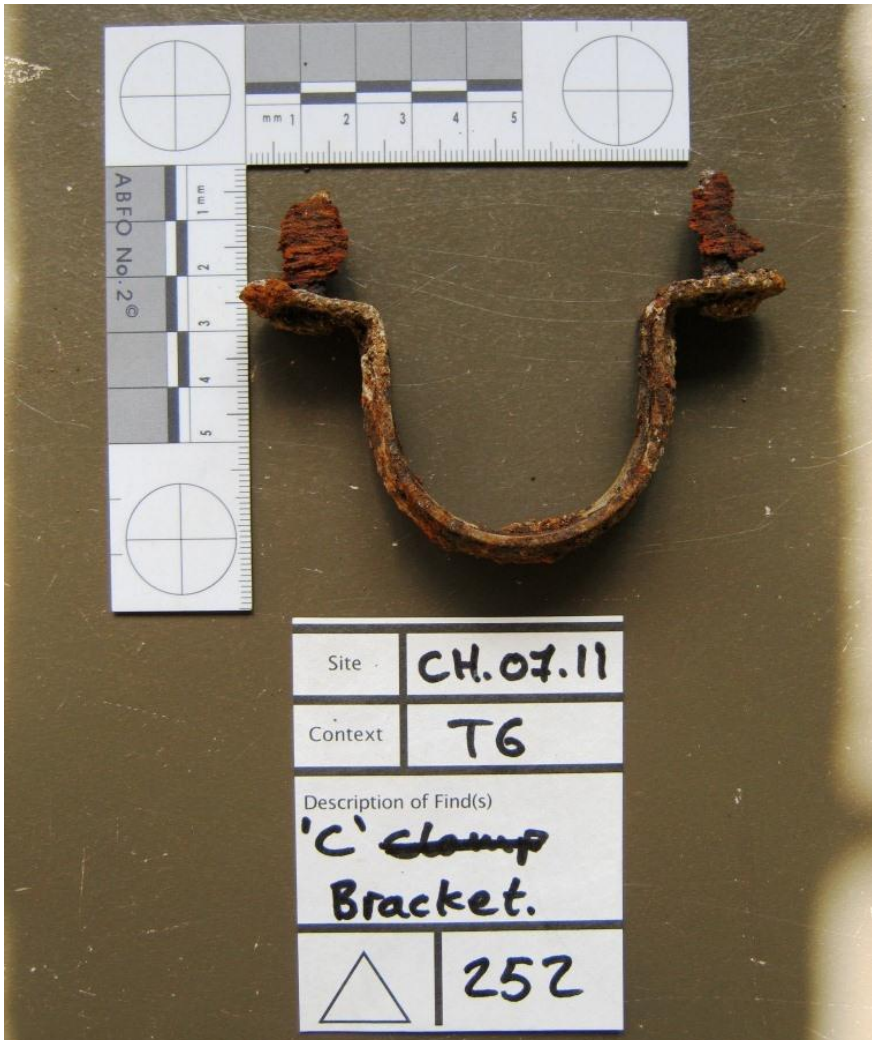
- No. 252 - a bracket for attaching a pipe to a surface. Reused to hold the vertically extending pipe work for the vertical lift door.

Photo 18: Find 252 – C bracket (Photo No. CH07-11-0225)

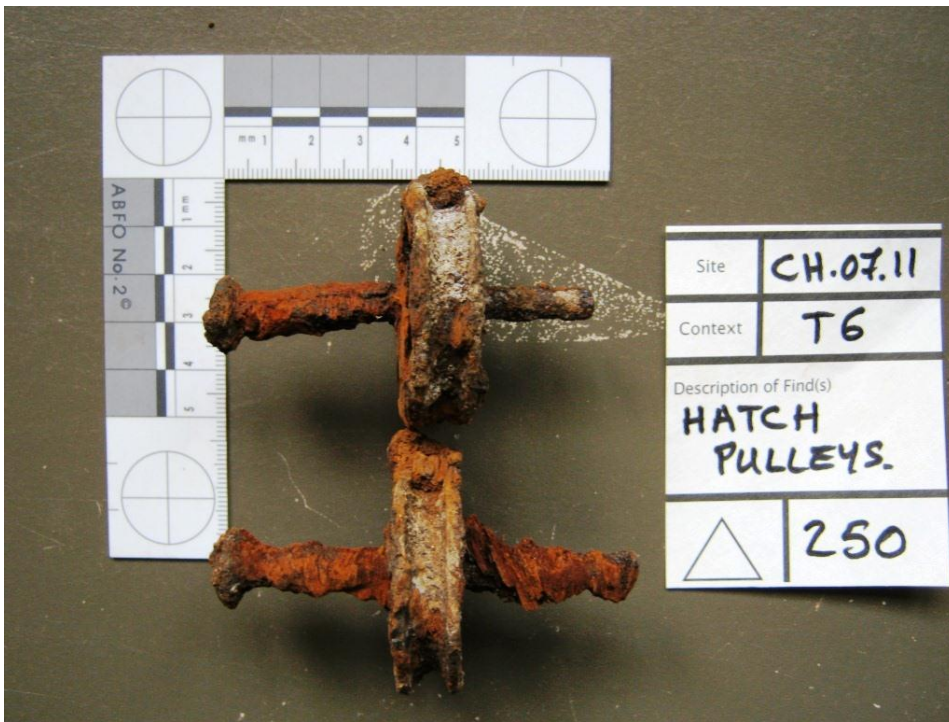
- No's 250 & 251 - sash window pulleys spindled on wood screws and packed with washers. Reused as part of the counterweight mechanism for the vertical lift door (see photographs on next page).

Photo 19: Find 250 – hatch pulleys (Photo No. CH07-11-0221)

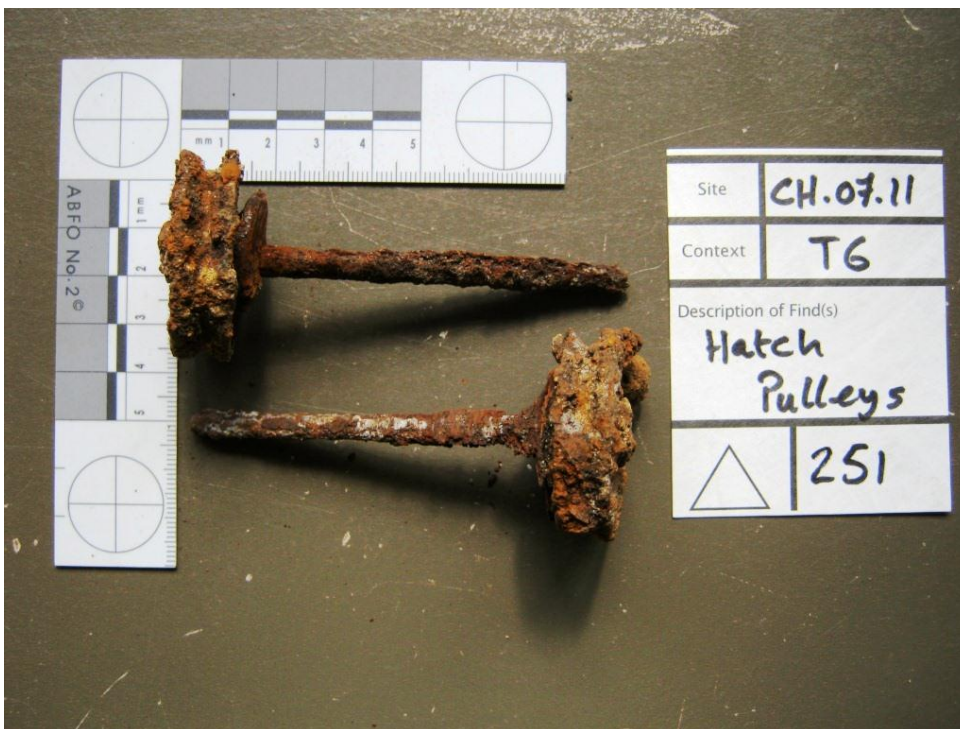
Photo 20: Find 251 – hatch pulleys (Photo No. CH07-11-0223)

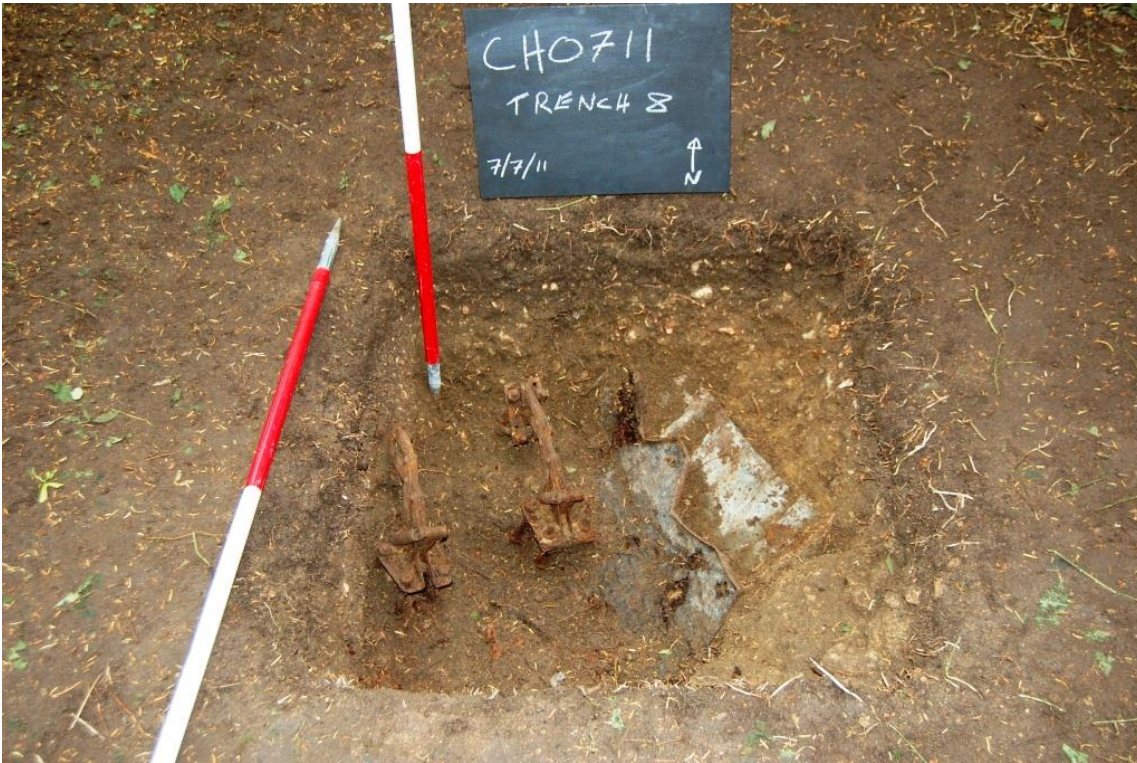
continued for a depth of 0.40m, at which point a piece of steel was revealed close to the northern edge of the trench. Careful cleaning showed the item to be a spring-loaded hinge mechanism, 0.30m in length at its' longest point. It was impossible to determine whether the mechanism was 'open', 'closed' or somewhere in-between the two, but the distance between the fastening plates on the inside was 0.11m. The edge of the item was 0.19m from the northern face and 0.25m from the western face of T8.

Photo 21: Trench 8 – facing north (Photo No. CH07-11-0063)

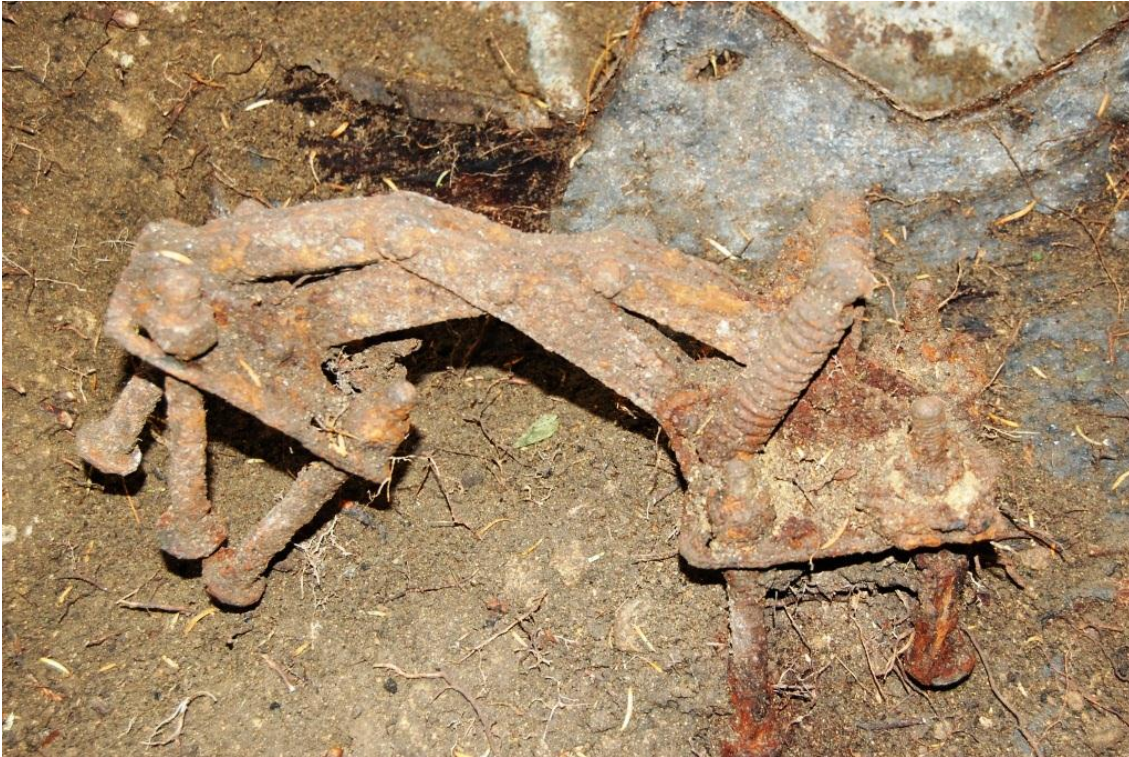
A matching item, with identical dimensions, was discovered, at the same height, 0.25m to the west and its' northern end was partially buried in the western baulk of the trench.

Photo 22: Trench 8 – close-up of spring-loaded hinge in-situ (Photo No. CH07-11-0068)

The two bracket mechanisms (that together make up Find No. 333) overlay an irregularly shaped piece of tin. The edges of this tin sheet had been bent over 0.03m to form a lip which appears to have been covered in wood and felt. The wood, which disintegrated when touched, seemed to fill the shaped tin and was covered by the, now hard and brittle, felt. Various nails and tacks were recovered from the area. This irregularly shaped construction overlay several large pieces of corrugated iron sheet. These were at various angles and continued into the trench baulk.

It is thought that these bracket mechanisms and the corrugated iron sheet make up a sprung lid for an underground hideout. The irregularly shaped iron sheeting may well be designed to look like a tree stump. The brackets would spring the door open and the car door handle may have been attached on the inside to lock the trapdoor shut again. If this is such a door, it has at some point been broken up and thrown into this hole. What we are unable to determine at this time is whether this is the original location of the door. Like the shaft discovered in Trench 6 is this the location of another training exercise to provide the Auxiliaries with examples of different types of doors or is it the location of another full OB? Ground Penetrating Radar may be used over this feature to determine if there are structures beneath the surface.

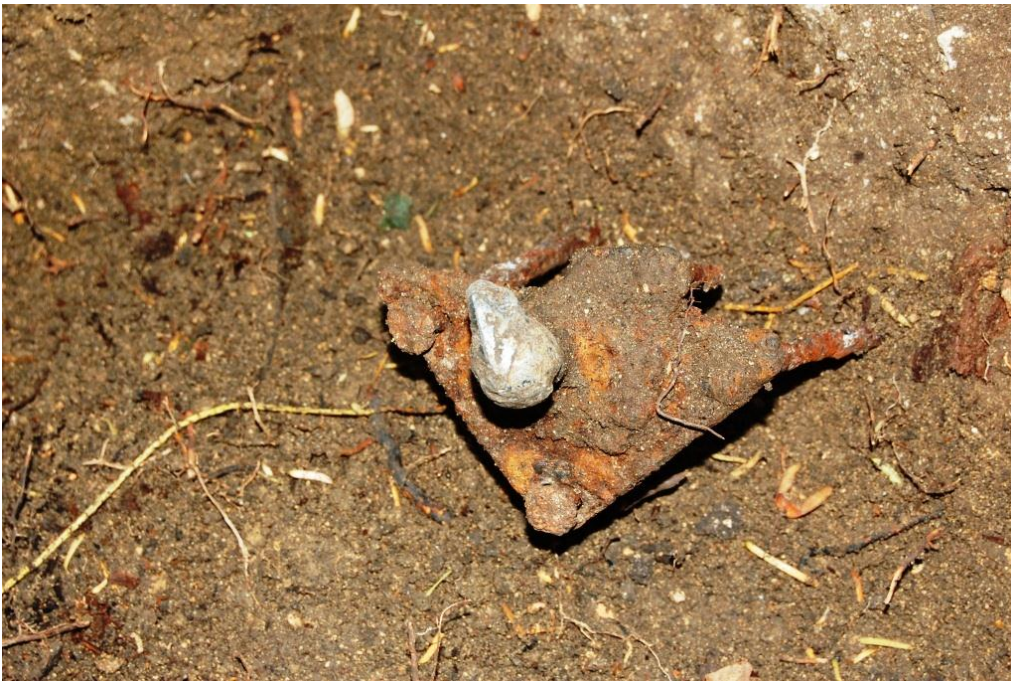
In the southern baulk, projecting northwards into the trench, a triangular piece of metal plate with pins and a broken stump of a car door handle attached to it was uncovered (see photograph on next page).

Photo 23: Trench 8 – close-up of handle in-situ (Photo No. CH07-11-0074)

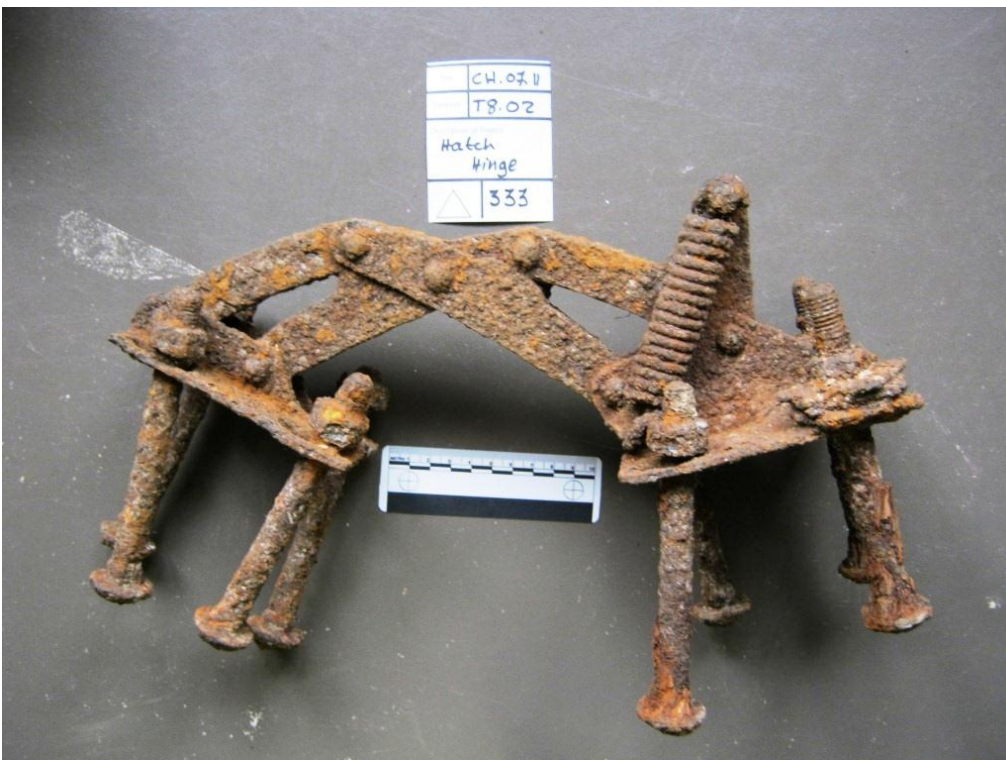
- No. 333 - a spring-loaded hinge (similar to an 'angle-poise' lamp), possibly from car boot. Reused as the hinges of a lift-up hatch.

Photo 24: Find 333 – hatch hinge (Photo No. CH07-11-0252)

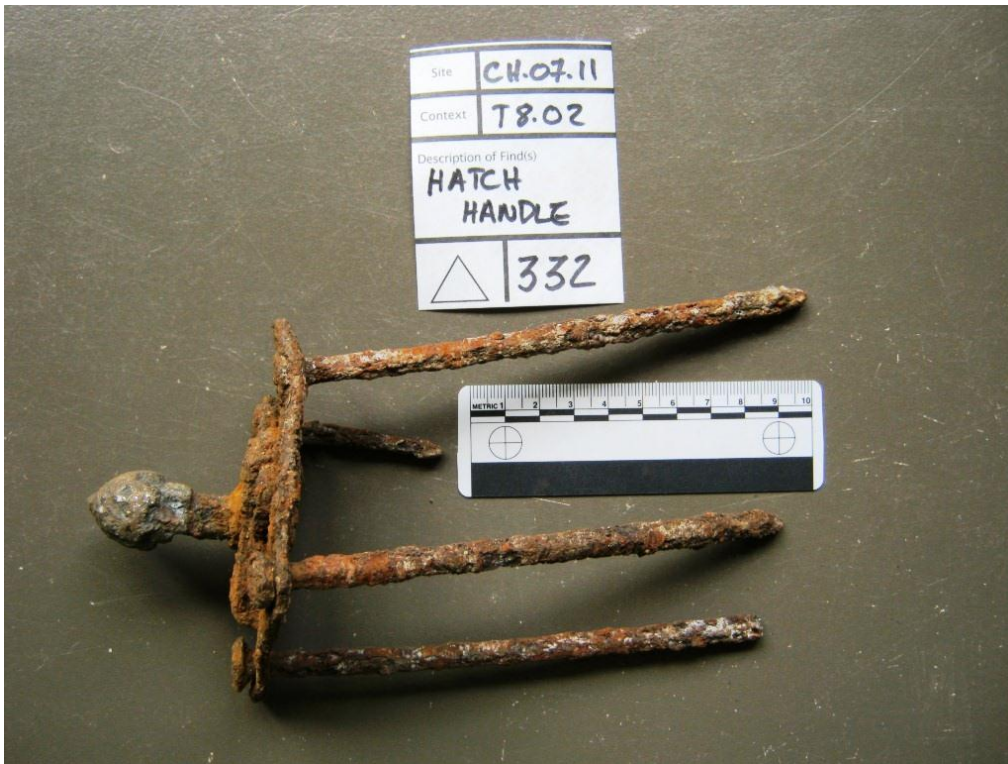
- No. 332 - chromed car door handle with attachment plate. Reused as a closing handle on the inside of a lift-up hatch.

Photo 25: Find 332 – hatch handle (Photo No. CH07-11-0255)

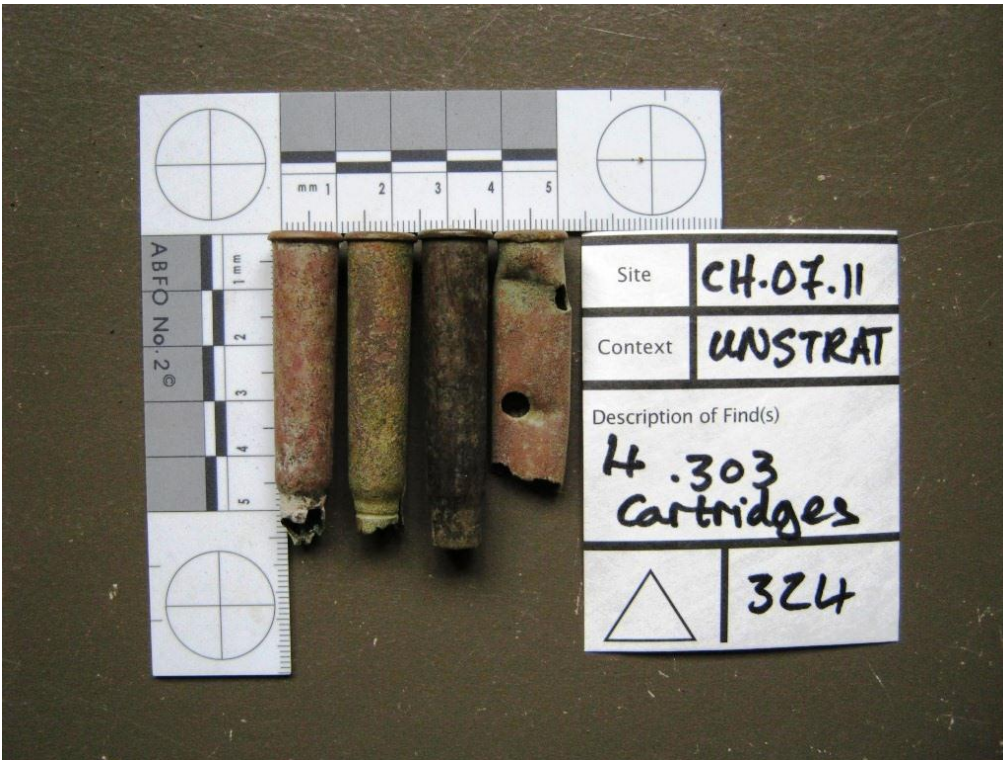
- No. 324 - Four 0.303 cartridges. One has been crimped and drilled; could this be an

Auxiliaries' improvised detonator?

Photo 26: Find 324 – 0.303 cartridge cases (Photo No. Ch07-11-0243)
