Coleshill Uncovered  
Season 1 fieldwork report  
July 2011

Issue 1.0, January 31<sup>st</sup> 2012

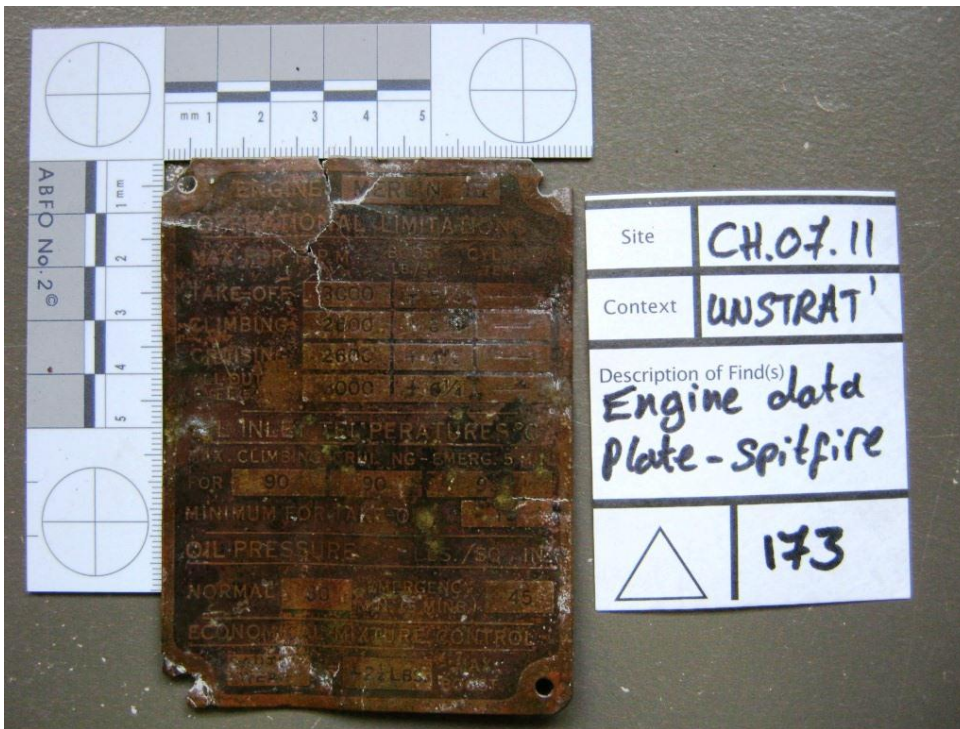
- No. 172 - Fragment from an Artillery shell nose fuse, believed to be an illumination round. Possible evidence of 3<sup>rd</sup> Air Landing Brigade (Royal Artillery)'s presence in the spring of 1944?
- No. 173 - "Operational Limits" data plate from a Merlin MK3 engine; probably from the Spitfire suspected of crashing in Cuckoo-pen Wood (see photograph on next page).

Photo 27: Find 173 – data plate (Photo No. CH07-11-0192)

Find No. 173 was a surface find and therefore not subject to the Preservation of Military Remains Act. Find No's 10, 91 and part of 39 (all from the January evaluation weekend) are also aircraft parts and having been recovered via metal detector, must be considered property of the Crown, under the Act, until notified otherwise (enquiries in progress).

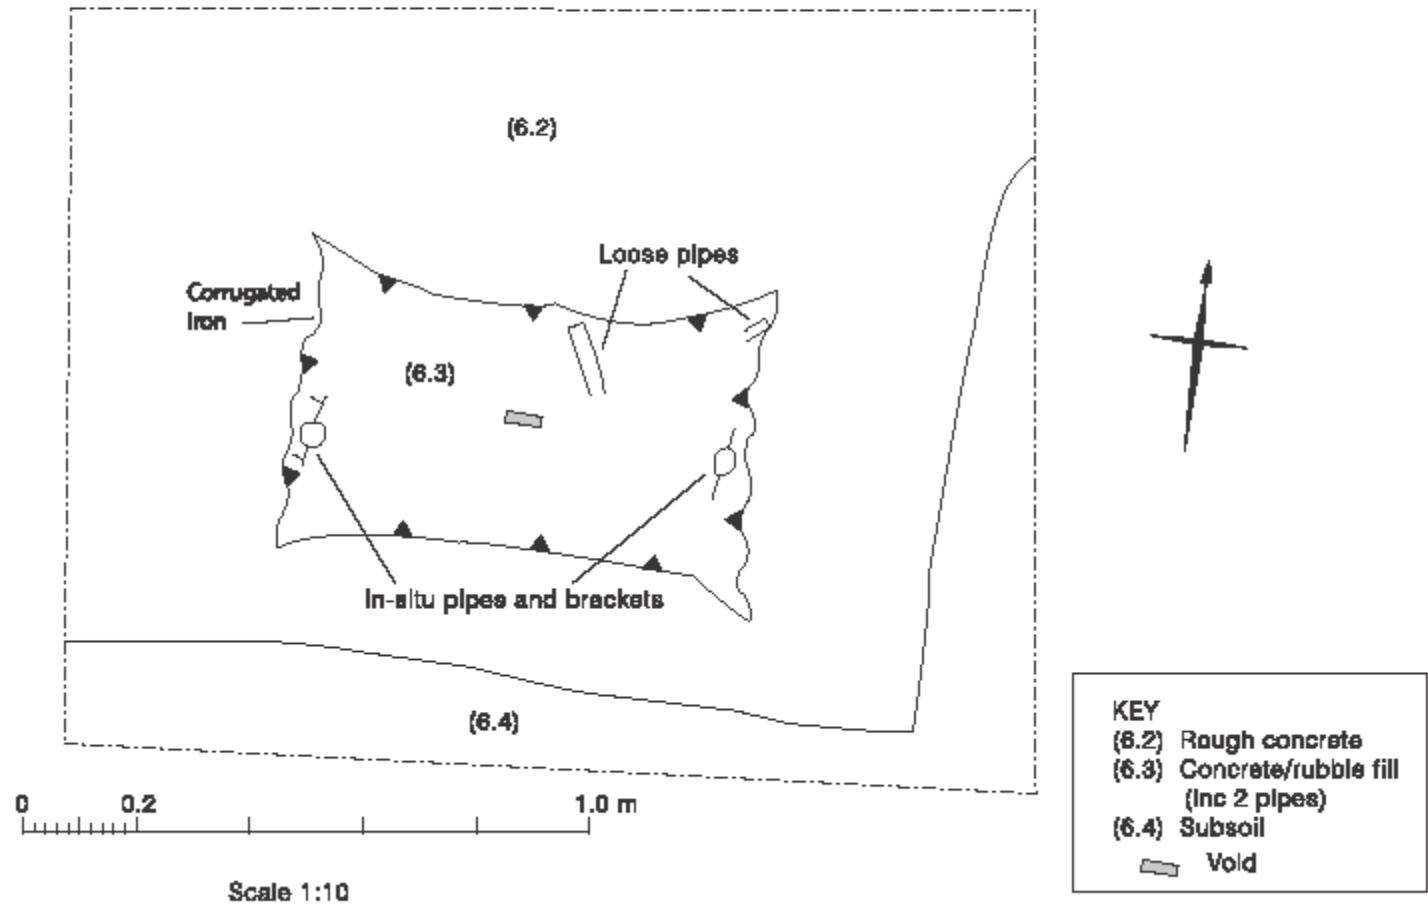
Appendix A  
Drawing 4

Ch 07 11  
Trench 3

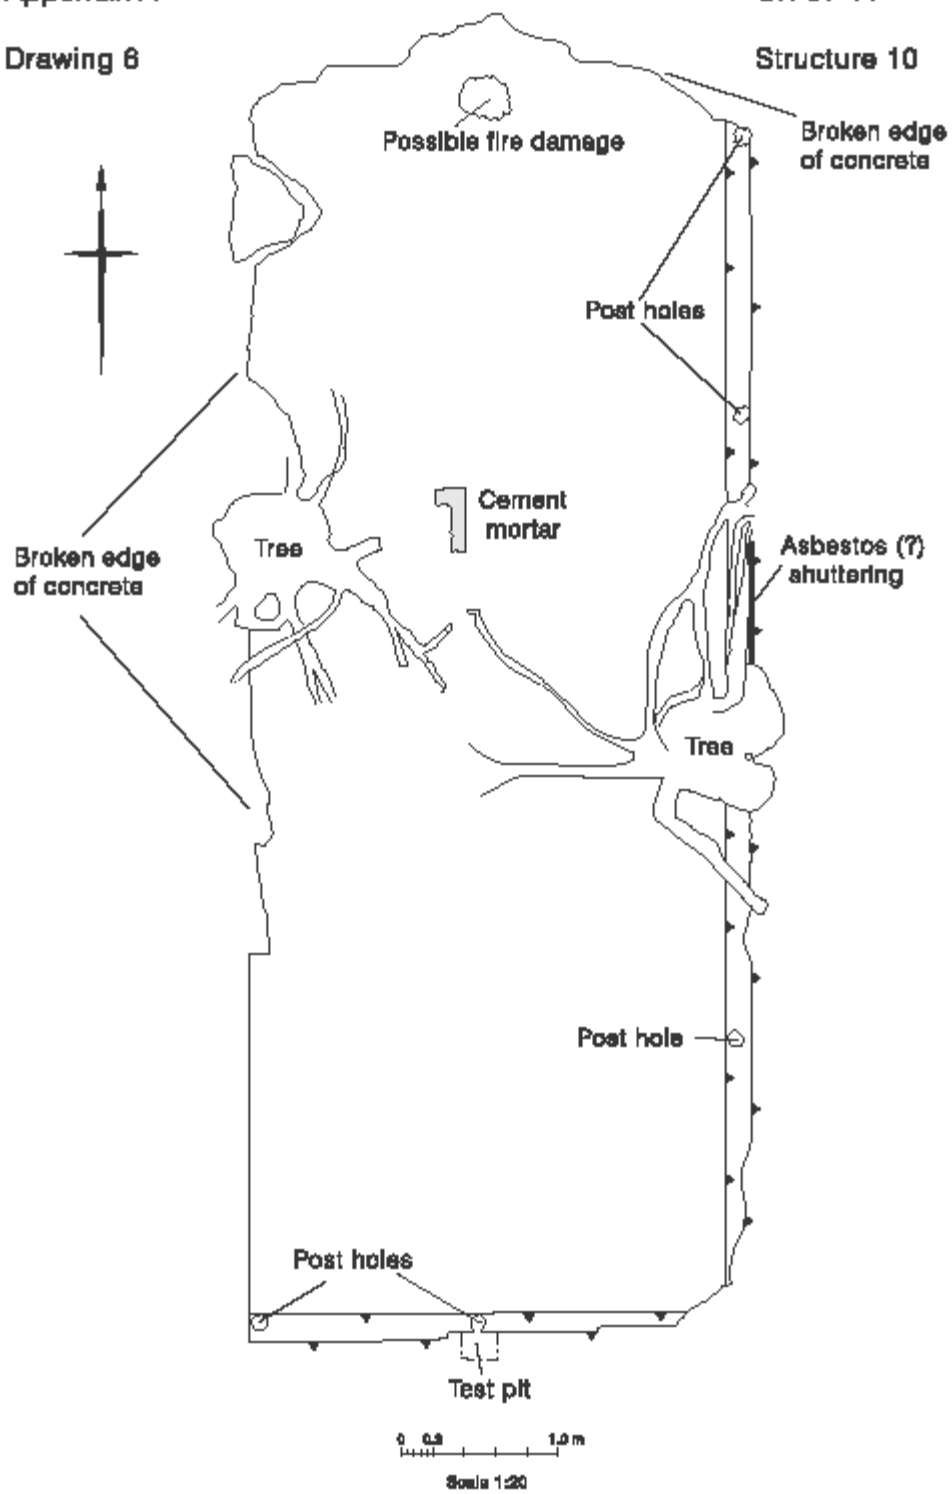
Drawing 6

Structure 10

Clearly another hut base, Structure 10 is longer and thinner than the other bases on site. The concrete lip situated on the southern and eastern sides may also have been located on the northern side of the platform (due to that end of the platform being broken we cannot confirm this). However the western side of the platform is intact at the southern end and there is no evidence of an outer lip here. It may be therefore that this structure was a three-sided hut, with the western side open to the elements. This different construction may well have been due to the use that the building was put to. Unfortunately nothing was recovered from the area that would provide us with clues as to what this use was.

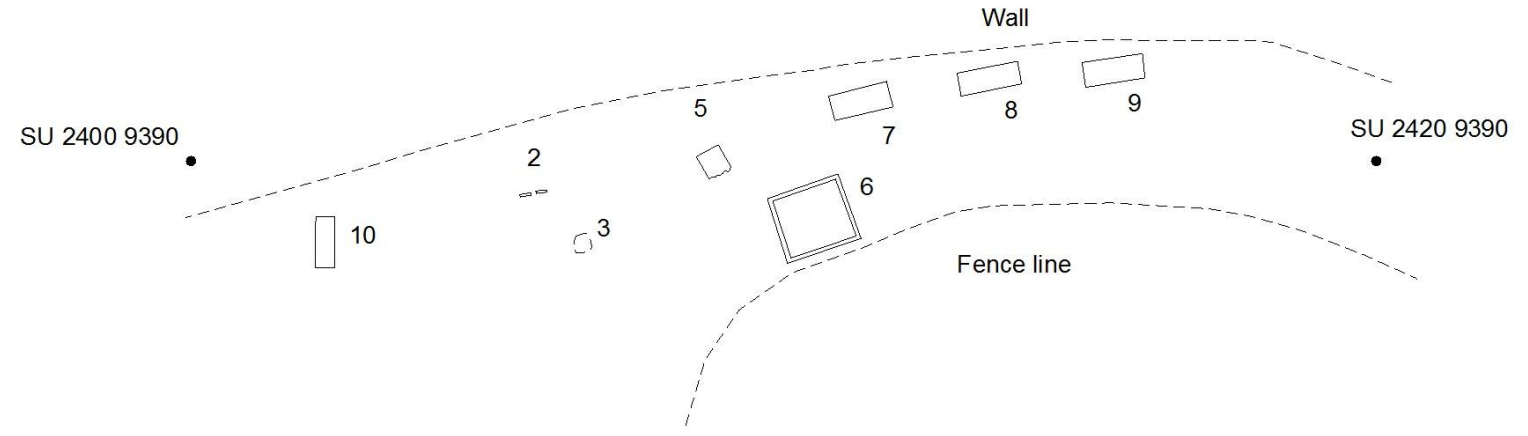
Appendix A  
Drawing 8

Plan of Structures in Sector 1

The site was surveyed at a scale of 1:200 using a Total Station. A base line was established and its position with the Ordnance Survey (OS) National Grid established by averaging 700 measurements from a navigation grade GPS receiver. The relative position of features are accurate to better than 100mm and the position within the OS grid to 3m. A 1:1000 scale (surveyed at 1:200) plan of Sector 1 has been produced from the data and can be found in Appendix A.

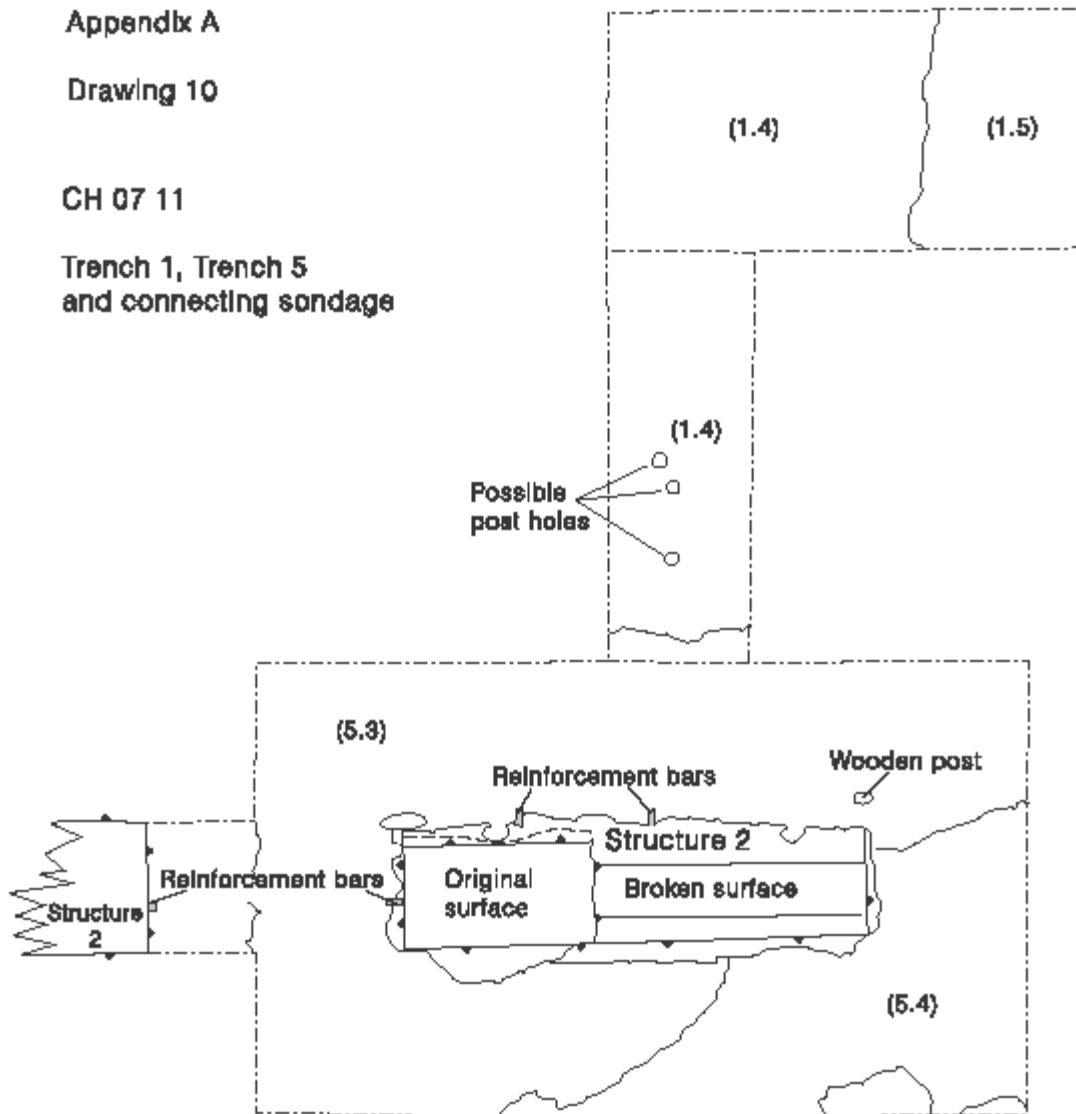
Drawing 10

Trench 1, Trench 5  
and connecting sondage

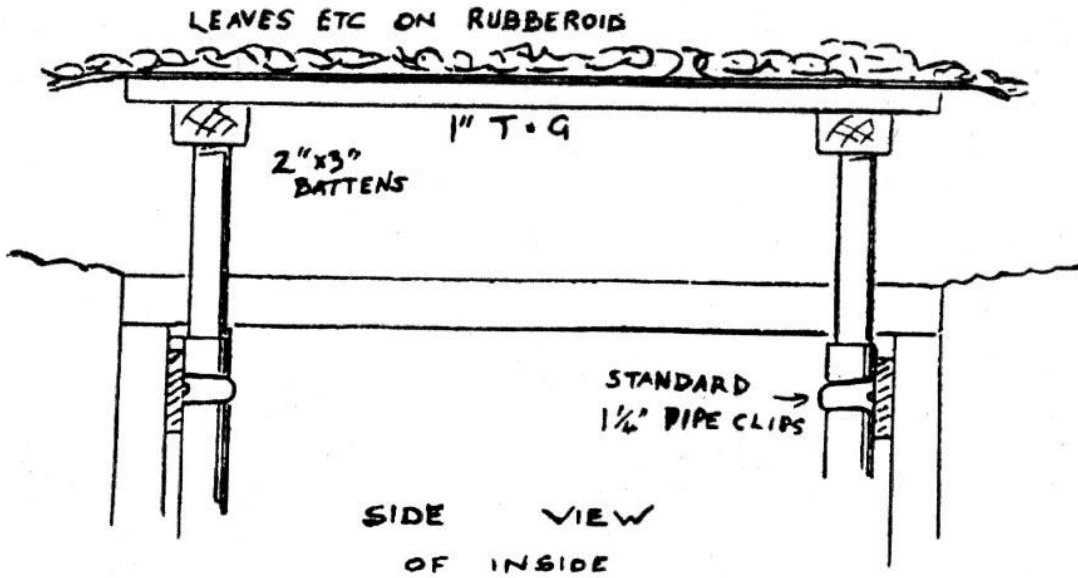
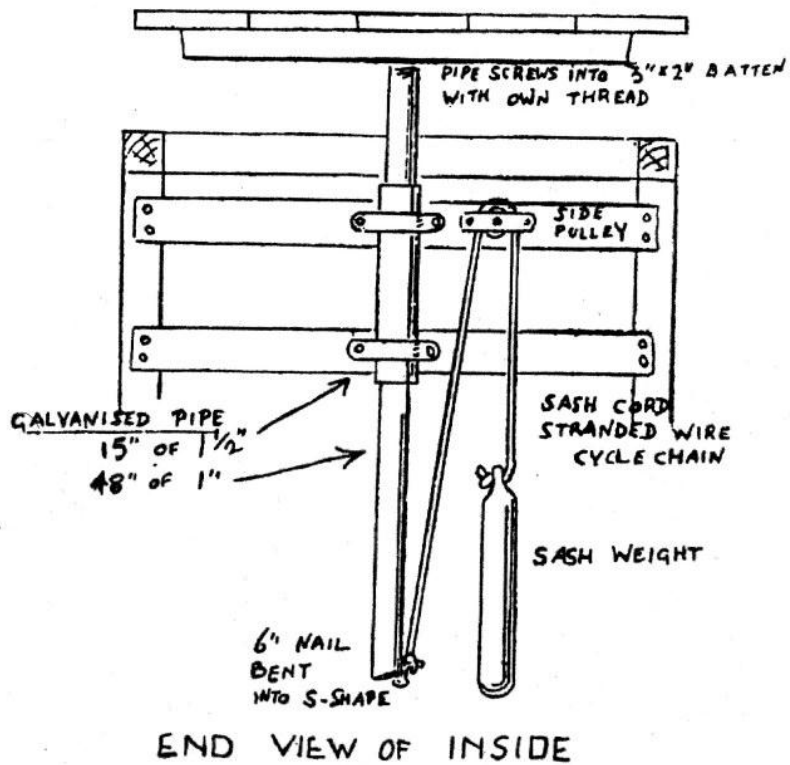
**Appendix C - Drawing of vertical lift door**  
 Kindly supplied by CART

**VERTICAL LIFT O.B. DOOR**

- No. 252 - a bracket for attaching a pipe to a surface. Reused to hold the vertically extending pipe work for the vertical lift door.

- No's 250 & 251 - sash window pulleys spindled on wood screws and packed with washers. Reused as part of the counterweight mechanism for the vertical lift door (see photographs on next page).
